**FATALITY ASSESSMENT AND CONTROL EVALUATION**

**Machinist Crushed by a Steel Spool while Working on a  
Hydraulic Lift Table  
Case Report: 04NY024**

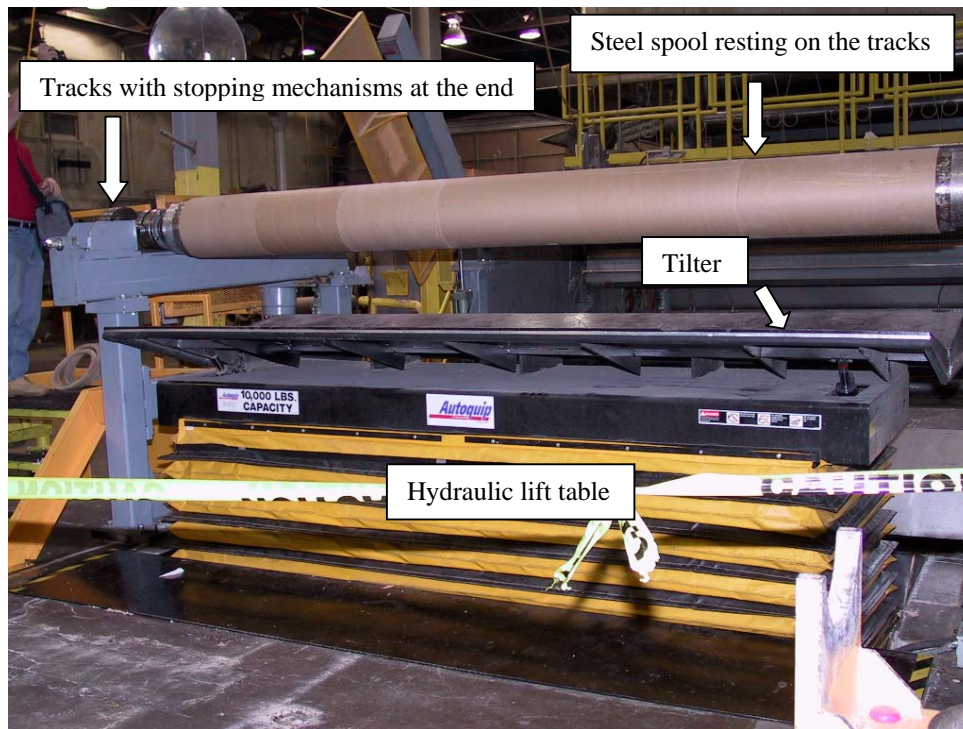
Located at the end of the tissue making line, the spool extractor unloads finished tissue rolls. It has three major components: a pair of tracks with stopping mechanisms at the ends, a hydraulic lift table and an extractor (Figure 1). A finished tissue roll on a spool travels downstream on the tracks that are 57 ½ inches high and is stopped at the end of the tracks by the stoppers. The hydraulic lift table, installed in a 17 ¾ inch-deep pit, lifts and raises the tissue roll to the height of the spool extractor so the spool can be retrieved by the extractor. The hydraulic table then lowers the tissue roll to ground level and releases the roll with a tilting device, or tilter.

Figure 1. Frontal view of the core extractor (the extractor is at the right of the hydraulic lift and not shown in the picture) including the spool and the lift position prior to the incident. The spool was resting on the tracks with the stopping mechanisms, and the lift platform was below the tracks.

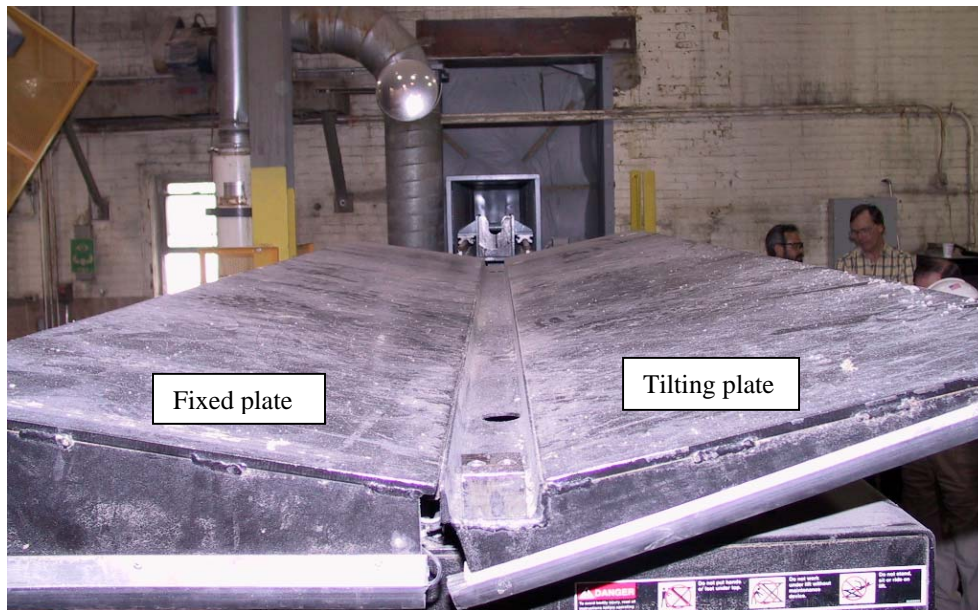
Figure 2. Tilter that was mounted on top of the lift platform.

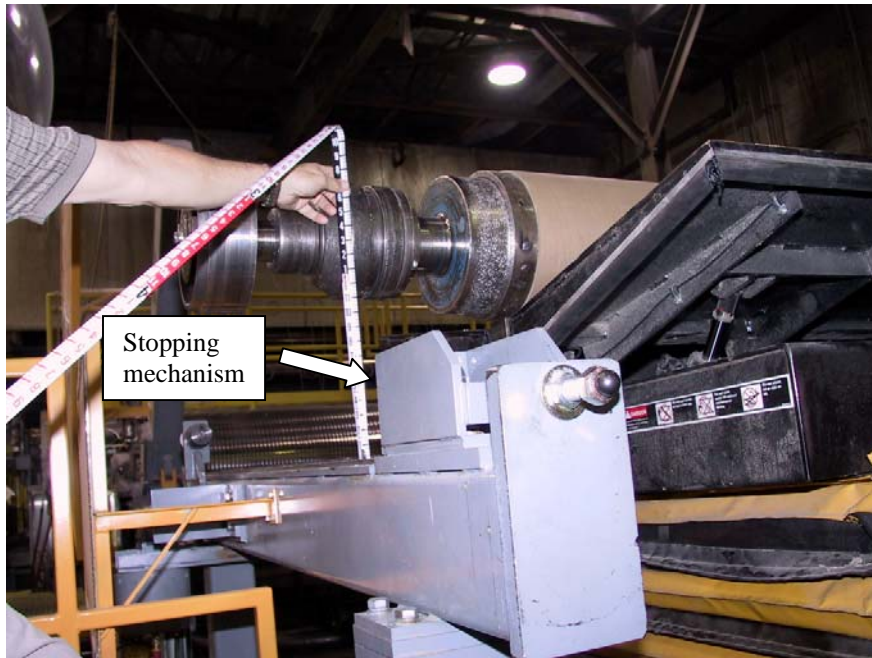
There was an overhead crane available in the unloading area and the machine shop staff had been authorized by the plant to use the crane. However, the machine shop crew did not use the crane to remove the spool from the table since it would be needed for testing the extractor later. The crew raised the lift table to approximately 74 inches above ground level. As the lift table rose above the tracks, it picked up the spool and held it with the tilter. The spool was raised approximately 11 ¾ inches above the tracks (Figure 3).

The maintenance leg was set up, but the lift was not lowered to rest in the leg socket as required by the manufacturer. The length of the maintenance leg was 48 inches. If the lift had been lowered to fully rest in the leg socket, the height of the workspace underneath the platform would have been approximately 43 inches. According to the machine shop staff, the space would have been too cramped to perform the task.

Figure 3. During the incident, the steel spool was above the stopping mechanism on the tracks and only held by the tilter.

The co-worker began loosening the hose with the wrench and the hydraulic fluid started leaking out. The co-worker heard the lift creaking. At that time he could partially see through the lift skirt that the victim was facing the lift, either bending or squatting with one hand on the lift. The co-worker did not see the steel spool strike the victim. He heard the spool hit the ground and saw the victim underneath the extractor. It appears that the tilter lost its hydraulic pressure as the damaged hose was released and the tilting plate came downward. The spool rolled off the tilter and hit the victim.

Employers should establish a safety policy or procedure that requires workers to remove loads that may endanger them prior to beginning equipment maintenance. This policy should be incorporated into the company's machine operation and maintenance safety manual. Companies should ensure that workers follow these safety procedures through proper training and close supervision.

**Discussion:** In the lift service manual, the lift manufacturer warned of the danger of going under a loaded lift platform and required users to remove all loads and securely support the platform with the maintenance leg. Neither of the requirements was followed in this case. Prior to allow employees to operate or perform maintenance on a new piece of equipment, it is important to train the workers to follow manufacturer's requirements and recommendations. The training should cover the following subjects:

**Discussion:** When the lift platform was lowered and set in the leg socket, the height of the working space under the platform was approximately 43 inches. Some workers may be reluctant to use the safety device because the cramped space may make it difficult for them to perform certain tasks. The lift manufacturer should consider increasing the length of the maintenance leg to create a larger workspace under the platform.
