**FATALITY ASSESSMENT AND CONTROL EVALUATION**

**Construction Laborer Dies after Falling off  
Collapsed Precast Concrete Floor Slab**

**Case Report: 07NY015**

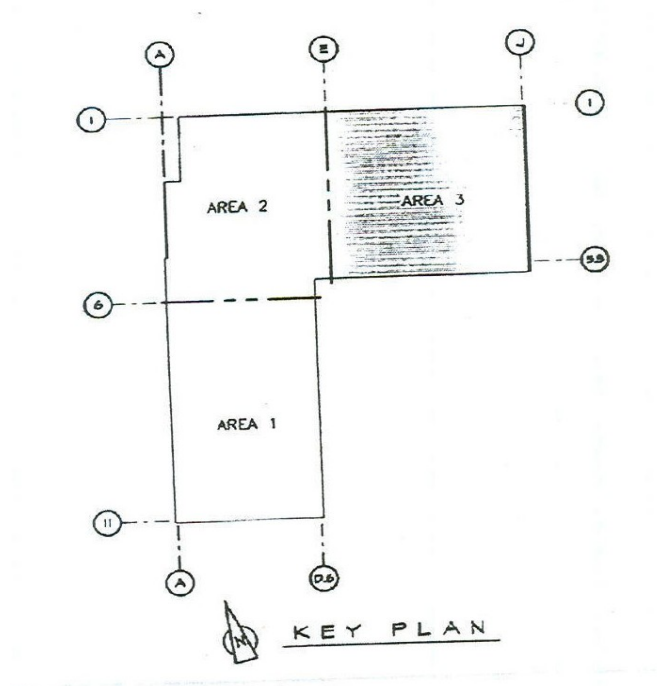
The construction of the building started in September 2006 and was divided into three areas (Figure 1). At the time of the incident, the company had completed erecting the steel structural framework and precast concrete slabs in Areas 1 and 2. In Area 3 where the incident occurred, the steel structure was erected and bolted up to the ninth floor of the ten-story building project. The precast concrete floor slabs were erected up to the eighth floor; they were neither grouted nor provided with additional welded steel support. Grouting and welding had been postponed at the time of the incident due to freezing temperatures.

Figure 1. The floor plan on the precast concrete ten-story building. (Illustration courtesy of OHSA)

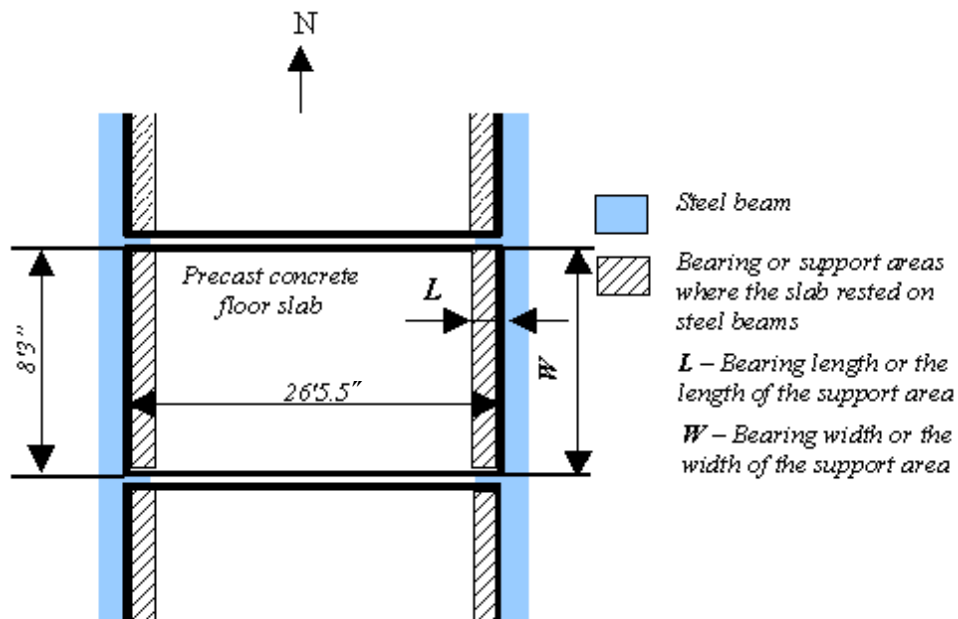
Each precast slab was hollow core concrete and measured 26' (feet) 5.5" (inches) long, 8'3" wide and 8" thick. Each slab weighed approximately seven tons. The floor slabs were oriented with their longitudinal (length) sides going east and west and supported by the horizontal steel beams on their transverse (width) sides (Figure 2). The hatched areas that were defined by L (bearing length) and W (bearing width) in Figure 2 represent the bearing or support areas where a slab was supported by the steel beams. The design specification dictated that each floor slab should have minimum length of the beam-supported area or bearing length of 3".

Figure 2. Precast concrete floor slabs positioned on steel beams.

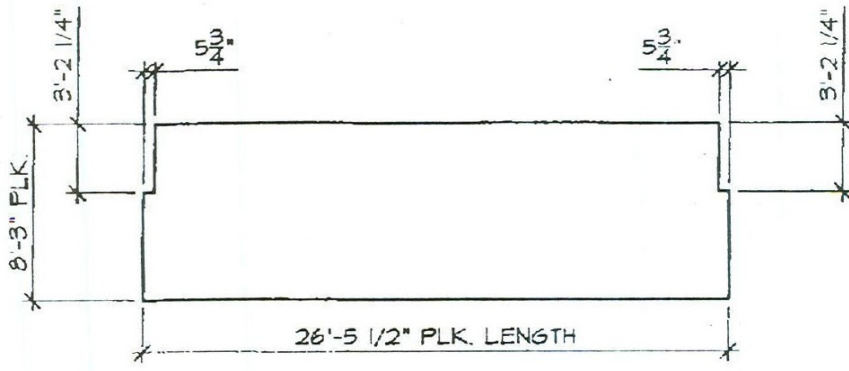
At approximately 9:20 am, the victim and the co-worker were aligning the third slab from the north side of the building on the 6th floor. The slab was located in-between two steel columns. In order to fit in the space, the slab was notched and had a section of 3'2 $\frac{1}{4}$ " by 5 $\frac{3}{4}$ " cut off on both corners on the north side. Figure 3 illustrates the measurements of the notched slab.

4. Proper reinforcements for the notched slabs including the one that failed initially were not provided, thus the structural integrity of these slabs was compromised.

**Discussion:** Oddly shaped slabs may require special erection procedures such as providing supplemental fastening. In this case, the failed slab was notched to fit in the space between two columns; it cantilevered more than 3’2” transversely. The design and strength of these notched slabs should have been carefully evaluated. Additional fastening or reinforcement to compensate for reduced beam support areas should have been provided. Project structural engineers should examine shop drawings thoroughly and ensure that the precast fabricators provide necessary supplemental supports.

Figure 3. The dimensions of the initially failed slab: a section of 5 3/4" by 3'2 1/4" was notched at both northeast and northwest corners of the slab to make room for the steel columns on both sides (courtesy of OSHA).

**Recommendation #5:** *The integrity and support strength of the odd shaped or notched precast concrete members should be carefully evaluated; supplemental fastening should be provided if necessary.*

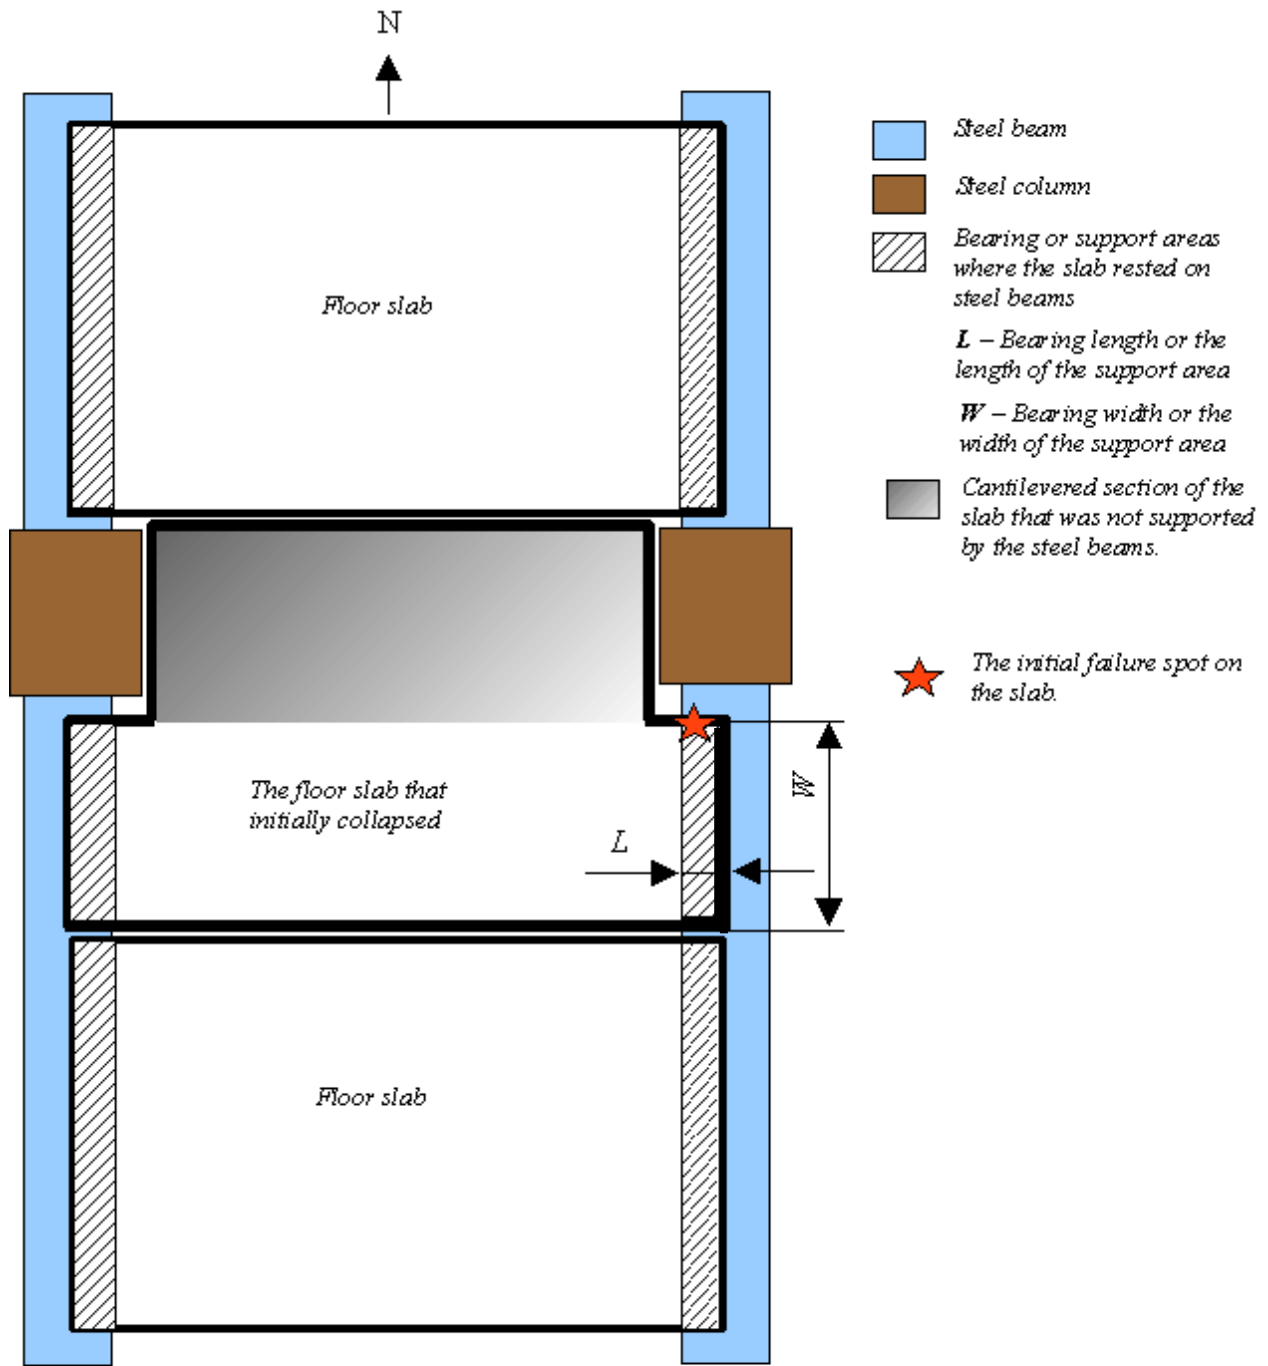
Figure 4 shows the top view of the positions of the failed slab and the two adjacent slabs on the steel beams and Figure 5 shows the connection detail of the failed slab. The shaded section of the failed slab in Figure 4 was suspended or cantilevered without the support of the steel beams. Due to its notched shape, the width (W) of the beam-supported areas bearing widths were reduced from the 8'3" (i.e. the full width of a floor slab) to 5'3 $\frac{3}{4}$ " on either side. Figure 5 shows that the specified design bearing length (i.e. the length of the beam-supported area) should be 3". The post incident investigation conducted by OSHA determined that the bearing length of this slab was only 1".

Figure 4. Top view of the positions of the initially failed floor slab and the adjacent slabs on the steel beams.

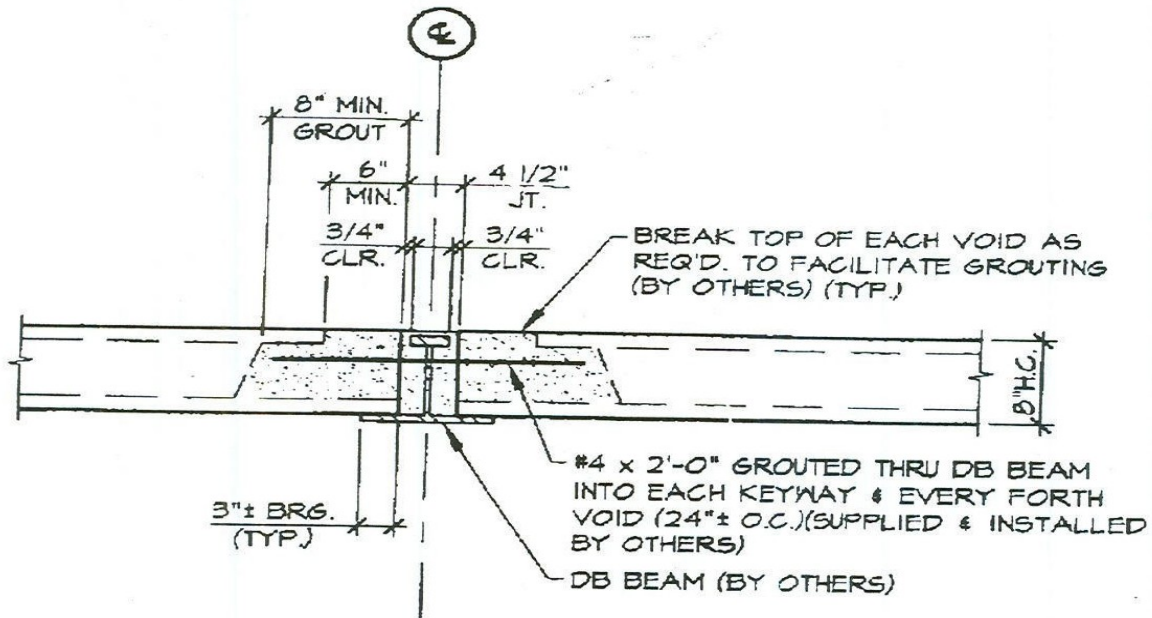
2. Six percent (6%) of the floor slabs surveyed by OSHA had shorter beam supporting areas or bearing lengths than the minimum 3" specified by the project structural engineer. The failed 6th floor slab had a bearing length of 1". The out-of-plumb columns had led to increased spacing between the columns and resulted in the reduced bearing lengths for the slabs located in-between these columns.

Figure 5. Connection detail of the failed slab: the bearing length of the slab was supposed to be 3" according to the design requirement (courtesy of OSHA).

**Recommendation #1:** *Employers should comply with the structural dimensions and tolerances specified by the erection design and check vertical and horizontal alignment of the steel structural frame before erecting any precast slabs.*

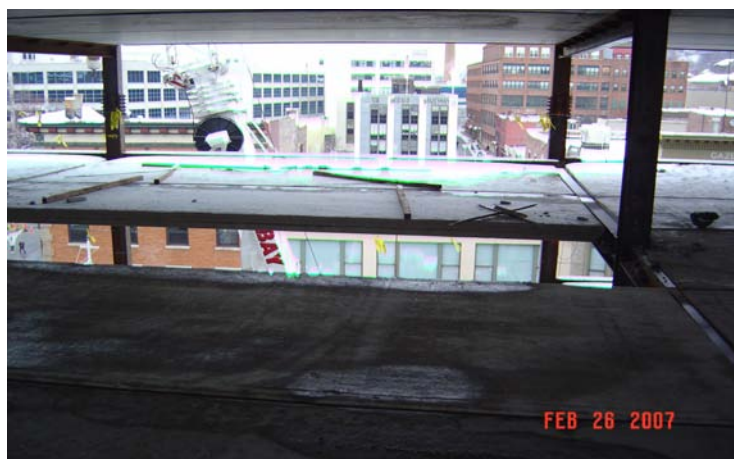
The initial collapse of the 6th floor (Photo 2) slab started a domino effect that continued to the ground floor resulting in the collapse of an additional five slabs (Photo 3). The collapsed slabs included one from each of the 5th, 4th and 3rd floors and two from the 2nd floor. The adjacent slab that was on the south of the collapsed area on the 4th floor was pushed to a vertical position and wedged between the supports (Photo 4).

*Photo 2. The initial collapsing zone on 6th floor. (Photo courtesy of OSHA)*

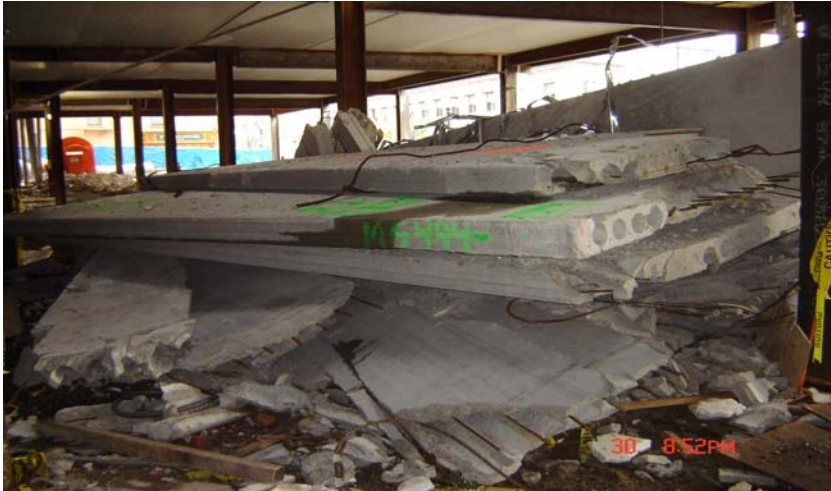
The floor slabs in this case were erected up to the eighth floor; the slabs were not grouted or supported with additional welded steel supports. This contributed to the domino effect that was initiated by the failed 6<sup>th</sup> floor slab.

*Photo 3. The domino effect started by the failed slab on the 6th floor crashing through the five floors below and caused the collapse of five more slabs to the ground level. (Photo courtesy of OSHA)*

**Recommendation #4:** *Precast concrete erectors should secure the precast slabs to the steel structural frame by the method specified in the erection plan as soon as the slabs are placed to their final position.*

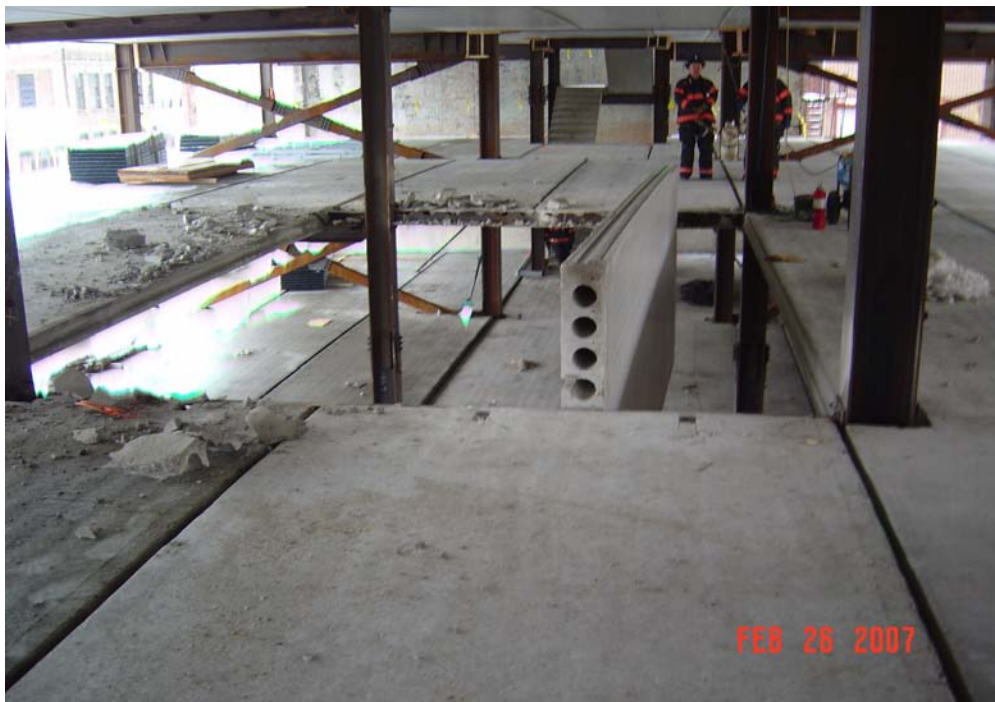
*Photo 4. A 4th floor slab adjacent to the collapsed zone was pushed to a vertical position and wedged between the steel beams. (Photo courtesy of OSHA)*
