FATALITY ASSESSMENT AND CONTROL EVALUATION

Metal Recycling Worker Run Over by a Front-End Loader at a Scrap Yard (Case # 17NY023)

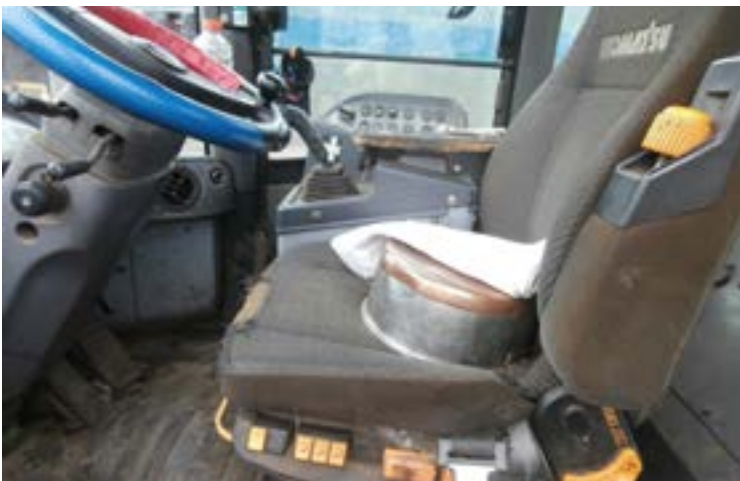
Photo 2. The loader operator's adjustable seat was broken, and the operator used a cooking pot as a booster seat (Photo courtesy of OSHA).

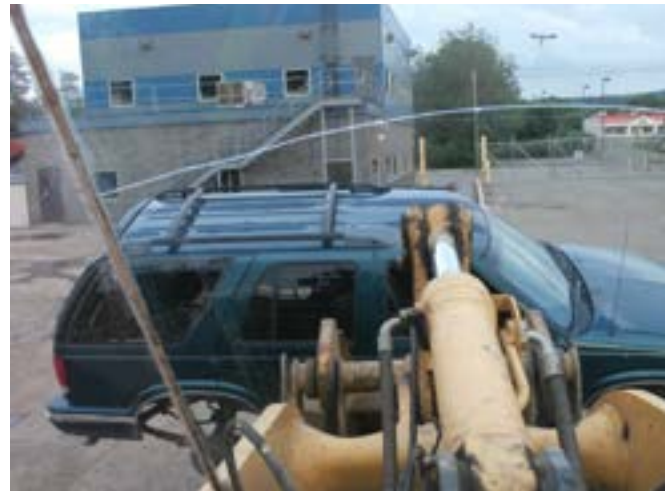
Photo 3. The front-end loader operator's view was blocked by the scrap car that had the tinted windows. There was a crack across the loader's windshield (Photo courtesy of OSHA).
