**FATALITY ASSESSMENT AND CONTROL EVALUATION****Restaurant Co-owner Fatally Crushed  
by a Dumbwaiter Car  
Case Report 12NY033****CASE SUMMARY**

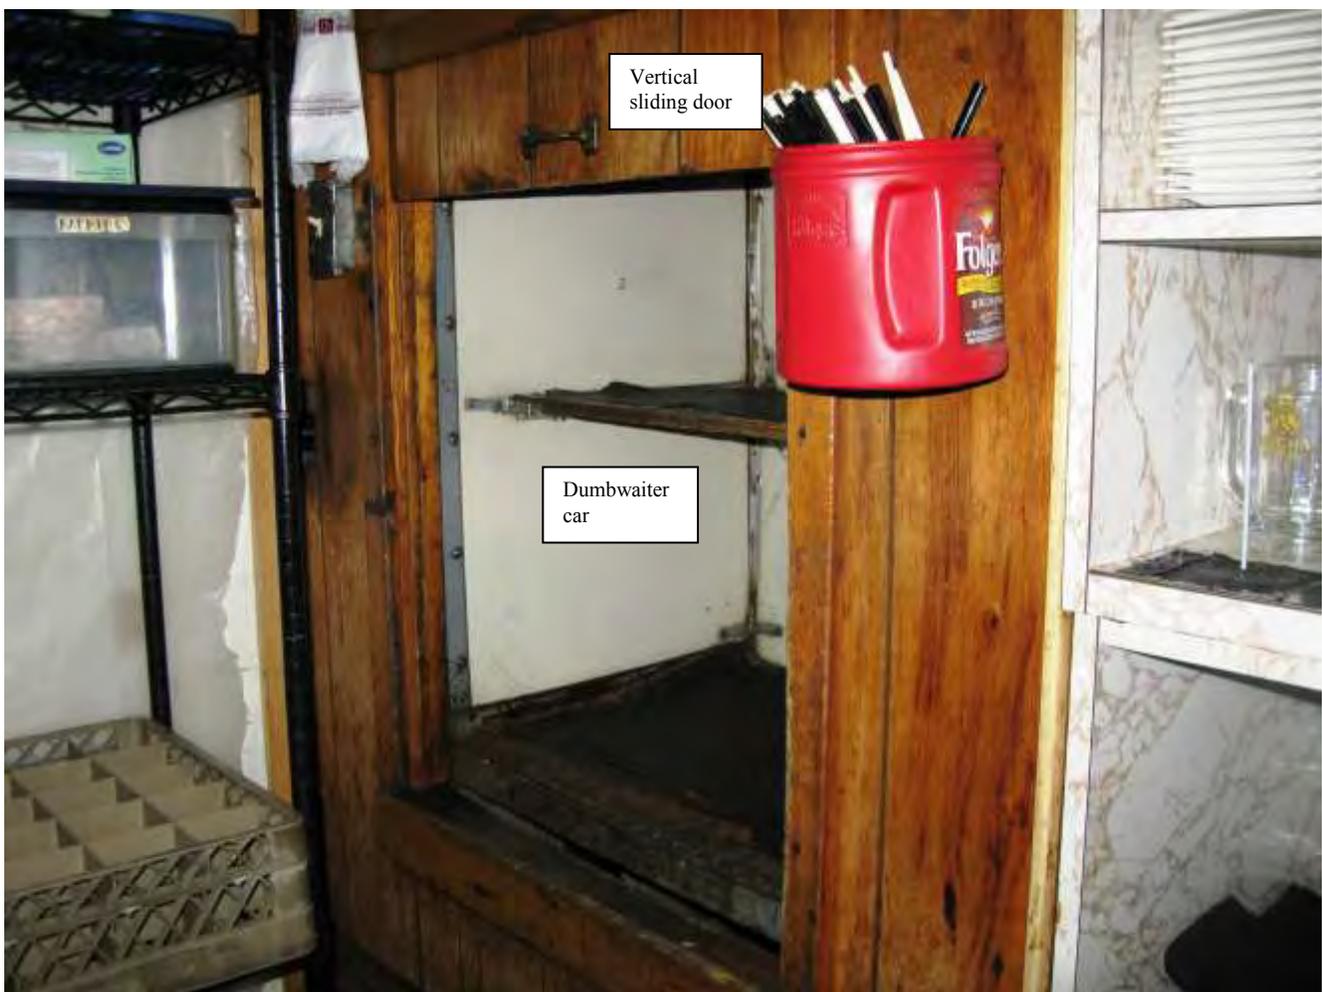
*Photo 1. The hoistway door opening in the upstairs food preparation area with the dumbwaiter car in the landing zone. The sliding door was nailed to stay in the up and open position.*

There was a hoistway access opening that had a vertical sliding door with a handle on each floor for loading or unloading the dumbwaiter car (Photos 1 and 2). The upstairs door opening was 26 ¼" x 31" x 29 ¼" (W x D x H). The bottom of the opening was 24" above the floor. The opening in the basement kitchen was 26 7/8" x 31" x 29 7/8" (W x D x H). The bottom of the opening was approximately 30" above the kitchen floor. There were two black press switches (one for UP and one for DOWN) and a red on/off flip power switch to the left of the hoistway door opening on each floor (photo 2).

The dumbwaiter at the restaurant did not have the interlock on either of the hoistway doors. The upstairs sliding door could not be closed because it was nailed in the up and open position. There were no signs on or near the dumbwaiter to warn users of fall or crushing hazards. When workers were first hired, they were shown how to operate the dumbwaiter and were told to stay away from the dumbwaiter when it was operating. They were supposed to check and make sure that the hoistway was clear of a person or unintended objects before activating the dumbwaiter car.

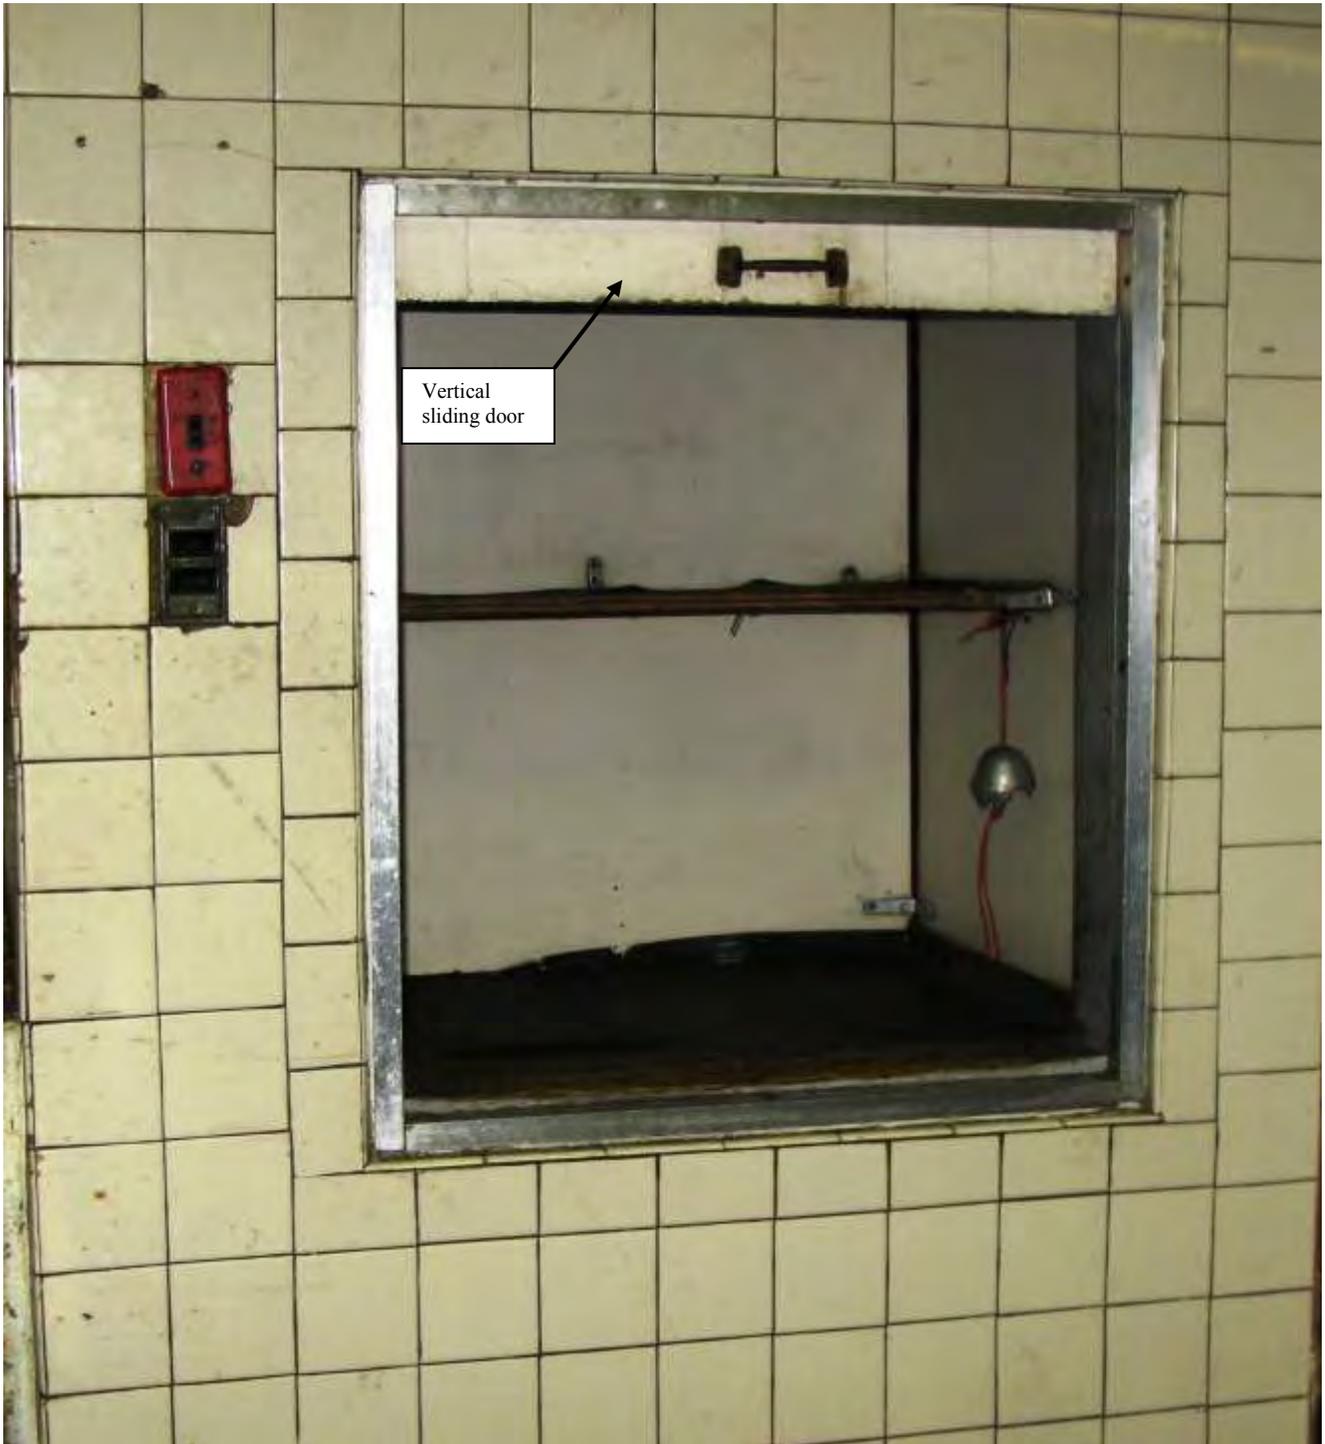
*Photo 2. The dumbwaiter hoistway door opening in the basement kitchen with the dumbwaiter car in the landing zone. There were two black press switches one for UP and one for DOWN and a red on/off power switch to the left of the opening. The bell attached to the rack in the car did not work.*

The dumbwaiter was used daily throughout each shift to transport food, dishes and other items between the upstairs food prep area and the basement kitchen. There was a bell attached to the shelf in the dumbwaiter car (Photo 2). Workers were supposed to ring the bell before activating the dumbwaiter to alert the staff on the other floor. According to the OSHA compliance officer who tested the bell, the bell did not work. Workers also used the dumbwaiter hoistway as a means of communication. They often leaned into the hoistway door openings yelling up or down to the staff on the other floor.
