REPORT#: 19NY038

REPORT DATE: 8/10/22

Mechanic Service Technician Fatally Struck by Order Picker Carriage — New York

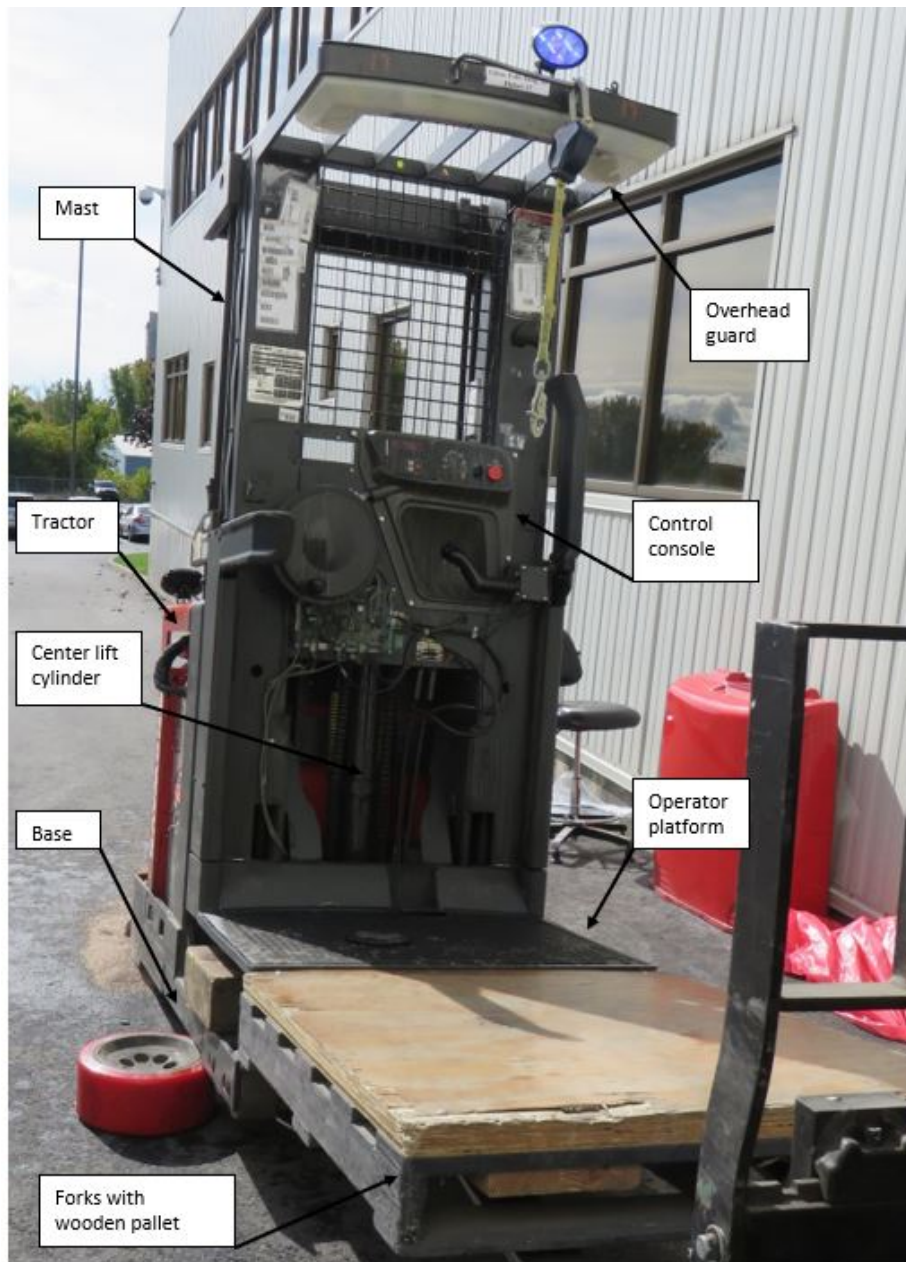
The chassis is the basic frame of the order picker: It is composed of the tractor, base, and mast (Photo 1). The carriage, which consists of the overhead guard, the control console, the operator's platform, and the forks, can move up and down on the mast. The carriage movement is actuated by a center lift hydraulic cylinder and a pair of side lift cylinders along with a set of chains and pulleys. The hydraulic pressure of the center lift cylinder was approximately 2,000 lbs. per square inch (psi), and the system hydraulic pressure is 6,000 psi.

Photo 1. The order picker that was involved in the incident with the console cover removed (Photo courtesy of OSHA).

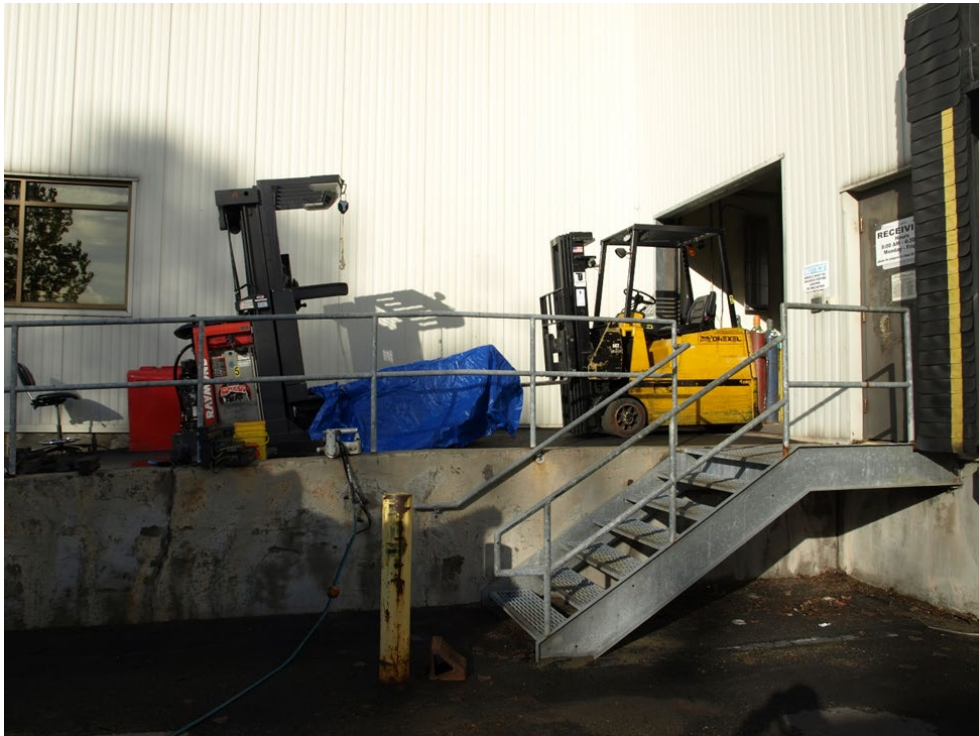
Photo 2. Post incident scene: The order picker was parked on the inclined ramp outside the loading dock during the incident. The forklift on the right was used in the rescue to lift the platform off the victim (Photo courtesy of city police department).

According to the co-worker, the decedent was holding a pair of snap ring pliers while standing directly underneath the elevated carriage that was neither chained nor blocked. At about 8:15 a.m., the decedent removed the outer snap ring with the pliers from the rod end apparently to verify the part number. The function of the outer snap ring (retaining ring) is to hold and secure the oil seal of the cylinder at the rod end. While the decedent was telling his co-worker that he just wanted to look at the ring, the carriage fell quickly. The decedent was crushed underneath the operator platform, and the hydraulic fluid sprayed the entire dock area.
