# STATE OF NEW YORK DEPARTMENT OF HEALTH

## FATALITY ASSESSMENT AND CONTROL EVALUATION

### Truck Driver Dies during Payloader Crushing Incident Case Report: 03NY036

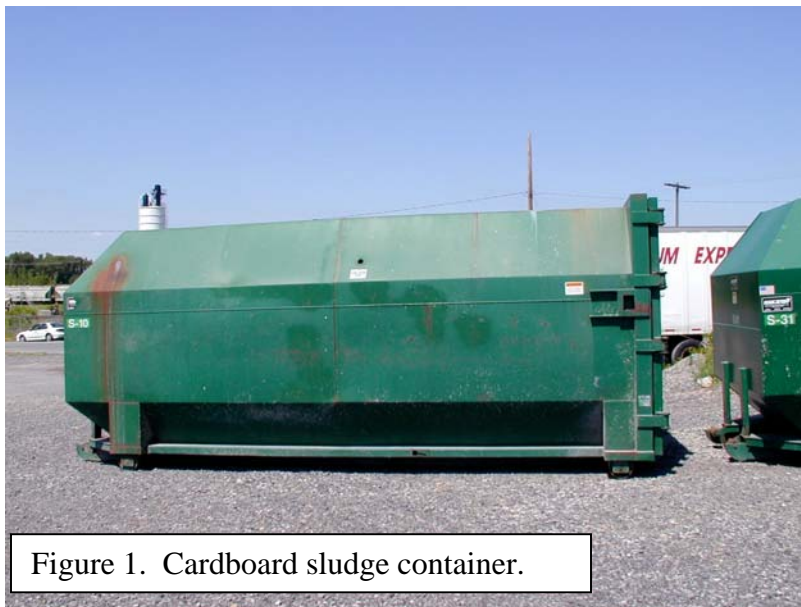
style back. This is similar to the style of trucks used with large dumpsters which are rolled off of the ground and onto the back of a truck for transportation. The cardboard sludge containers were self-contained units measuring 24 feet long (Figure 1) that were placed inside the cardboard manufacturing plant. When the units were full, they were pulled onto the back of the truck. At the

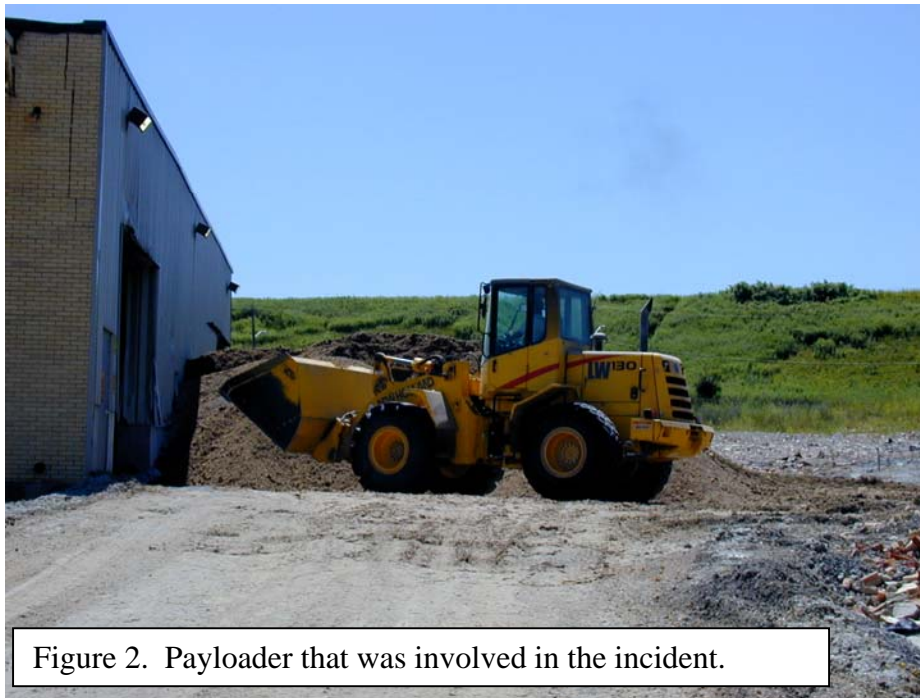
Figure 2. Payloader that was involved in the incident.

At the time of the incident, the payloader was in good condition and had rearview mirrors present on both corners of the operator's cab. The fact that the shift change had just occurred and the payloader operator had just reported to work may also have contributed to the incident since the truck had been present and unloaded prior to his arrival for his shift. The operator was unaware that a truck was present at the pad as he backed out of the door and made the turn. The area immediately outside of the doorway of the building is visible from the inside of the building, but the area where the dump truck was parked was perpendicular to the doorway opening, and was not visible from the inside of the building (Figure 3).

Upon inspection by police and OSHA investigators, the back-up beeper of the payloader was not sufficiently audible to be heard while the engine was operating. Later that day when the payloader was checked again, the back-up beeper was operating at a louder and normal level. The business manager stated that the back-up beeper had been working prior to the incident although it is not known whether it was working immediately before the fatal accident occurred. It is possible that the back-up beeper was damaged during the collision since it was located in the rear grille cover which was the general area of impact. The company subsequently replaced the back-up beeper.

**Recommendation #3:** *Safety devices should be checked at each shift change to ensure proper operation. Additional safety devices should be installed in areas of high traffic.*

**Discussion:** In this scenario, safety devices such as backing beepers and lights may not have been working properly at the time of the incident. These devices should be checked at the shift change of each operator to ensure their proper operation. Additional safety devices on the building and loading area such as convex mirrors and flagging could be used to help identify when other vehicles are in the area.

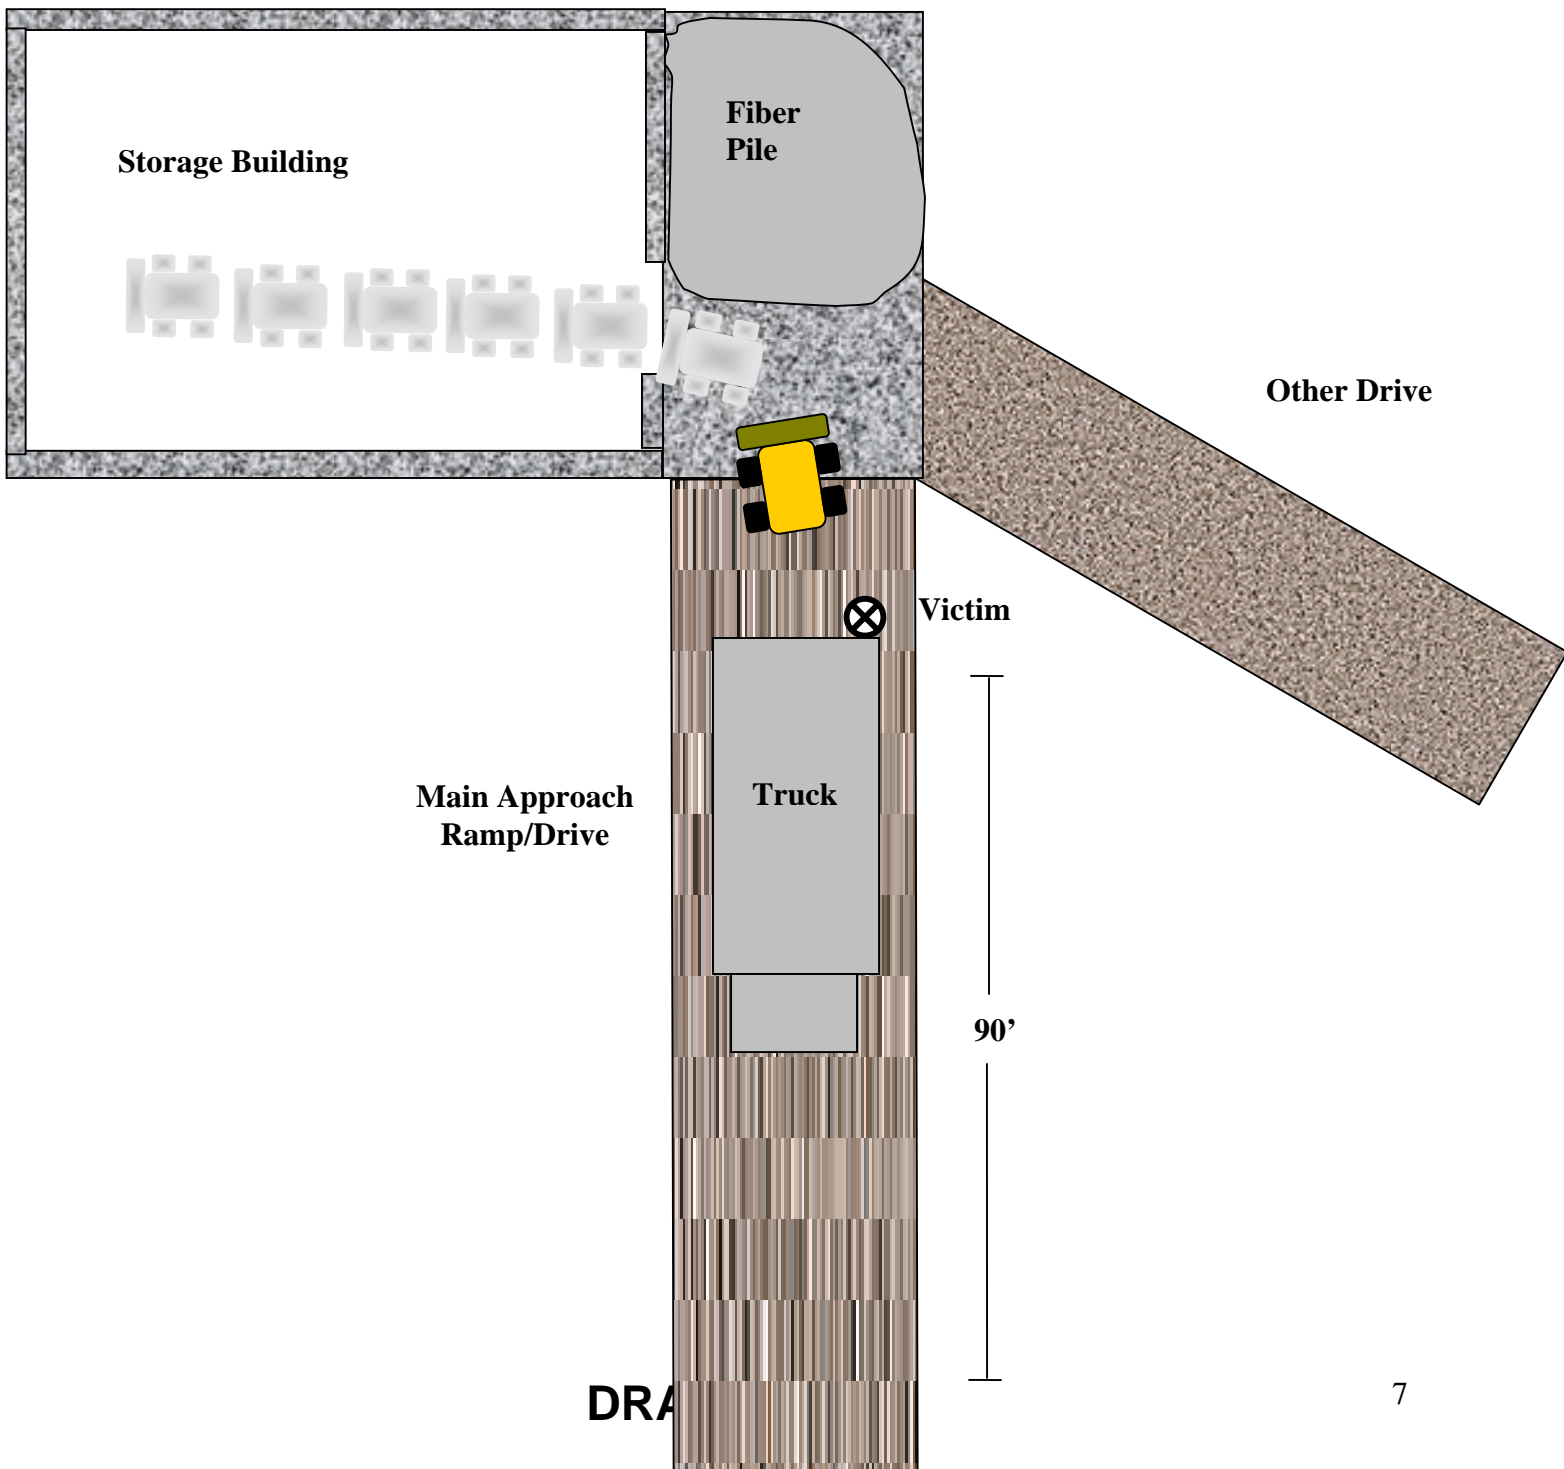
Figure 3. Diagram of Incident

pad. As he backed out of the building he made a 90-degree turn in order to position the payloader for scooping the material prior to transporting it back into the building (Figure 3). As he backed out of the doorway and made this 90-degree turn, he heard a bang and then a loud scream. The operator then saw that the delivery truck still remained at the unloading area. He also saw the victim lying on the ground about 10 feet from the back end of the delivery truck. The payloader operator

Upon re-creation of the incident, it appears that the payloader operator did not expect a vehicle to be present near the loading pad. Commonly, trucks unload at the unloading pad and then pull away from the area in order to secure the tailgate before proceeding onto the roadway. On this particular day, the victim unloaded his truck and then pulled to the edge of the unloading pad before securing the tailgate prior to departure. This left a space of only 29 feet between the edge of the cardboard pile and the back end of the dump truck. The payloader was 24 feet in length.

**Recommendation #1:** *Facilities should be properly designed and unloading procedures modified to promote safety.*

**Discussion:** The unloading area of the facility involved in the incident had two ramps that were used; one was angled 90 degrees to the door opening, and the other was directly across from the door opening. The unloading ramp that is directly opposite the door opening is the preferred design because it allows the payloader operators to see any trucks remaining in the area prior to exiting the building.
