# STATE OF NEW YORK DEPARTMENT OF HEALTH

## FATALITY ASSESSMENT AND CONTROL EVALUATION

### Department Store Employee Crushed In a Baling Machine Case Report: 04NY013

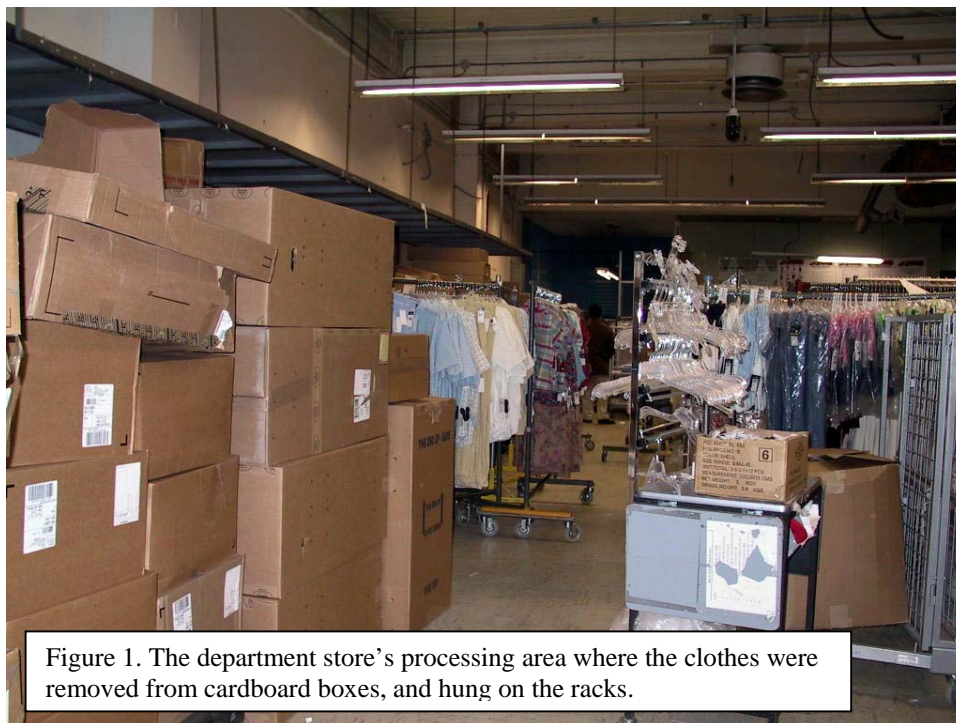
Figure 1. The department store's processing area where the clothes were removed from cardboard boxes, and hung on the racks.

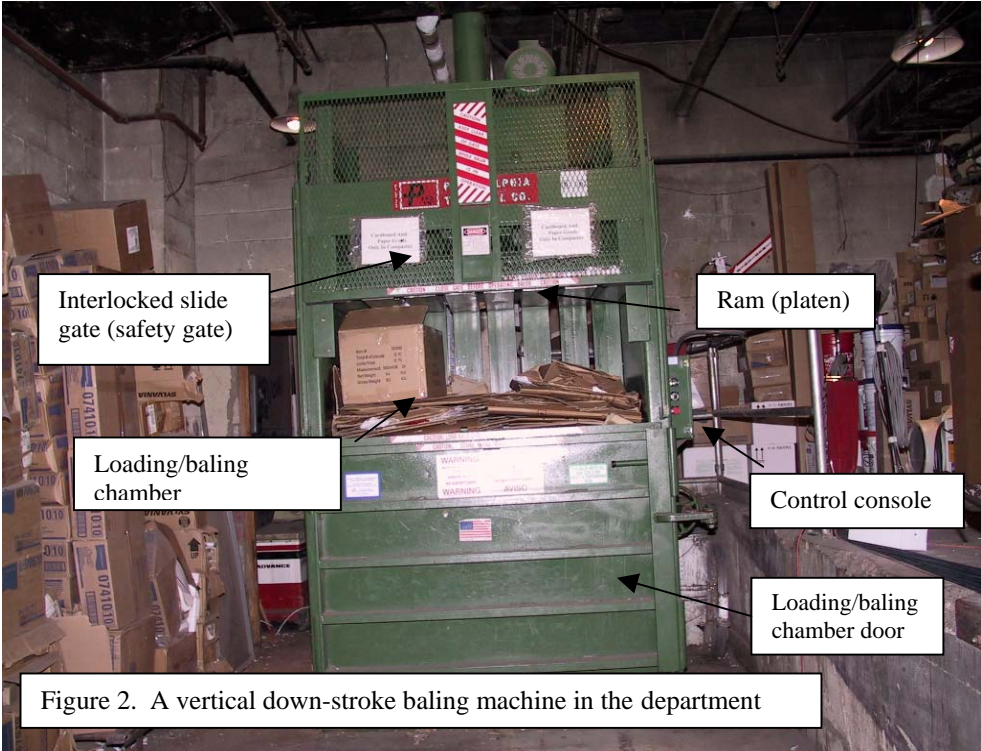
The baling machine was a vertical down-stroke baler (Figure 2), consisting of a ram (platen), an interlocked slide gate (safety gate), a loading/baling chamber, and a control console. The baler utilized hydraulic pressure generated by a 10-horsepower electric motor and a hydraulic pump to compress materials. The completed bales, measuring 60 by 30 by 48 inches, weighed between 850 and 1100 pounds. The control console (Figure 3), located at the right side of the baling machine, had a key switch for turning the machine on or off, a push button for moving the ram up or down, and an emergency stop button.

The baler was equipped with safety devices designed to meet the American National Standards Institute's (ANSI Z245.5) requirements for Baling Equipment-Safety. Specifically, the machine was equipped with a safety proximity switch located in the middle of the lower side of the vertical sliding safety gate. The safety switch was interlocked with the power to the motor and hydraulic pump so that when the gate was fully down and shut, the interlock would engage allowing operating power to the motor and the hydraulic pump. When the door was up and open, the interlock switch cut the power to the motor and the hydraulic pump which immediately stopped the ram from moving.

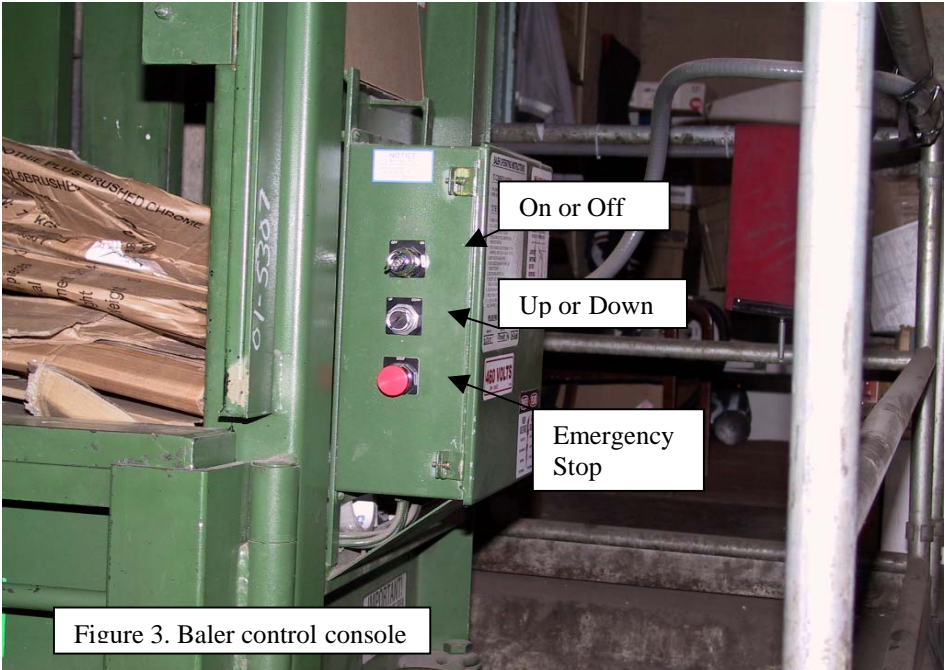
An OSHA compliance officer observed a broken key in the baler’s “On or Off” key switch on the day of the incident. A post-incident baler examination found that the electrical wiring had been altered to bypass the “On or Off” switch, and the gate safety switch had been short-circuited by a piece of two-inch wire. By doing so, power was always supplied to the machine and the baler could operate with

the safety gate up. It could not be determined during this evaluation who modified the baler's electrical circuit, when these alterations were made, and what the intent was.

**Discussion:** Although the company conducted storewide safety inspections twice a month, the inspections did not identify the bypassed safety devices on the baling machine. The safety switches and interlocks on baling machines are designed to protect operators from being injured by the movement of the ram. Bypassing these safety devices increases the potential risk for severe injuries such as crushing or amputation, and in this case, resulted in a fatality. To help ensure operator safety, employers should inspect all baling and compacting machines periodically to ensure safety features are working properly. A baler inspection checklist with specific instructions on how to perform safety device checks should be developed. The results of each inspection should be documented and the records maintained. Balers with malfunctioning safety devices should be removed from service immediately until repairs are completed.
