STATE OF NEW YORK DEPARTMENT OF HEALTH

FATALITY ASSESSMENT AND CONTROL EVALUATION

Three Construction Workers Killed after being Struck by a Bus in a Highway Work Zone Case Report: 05NY039

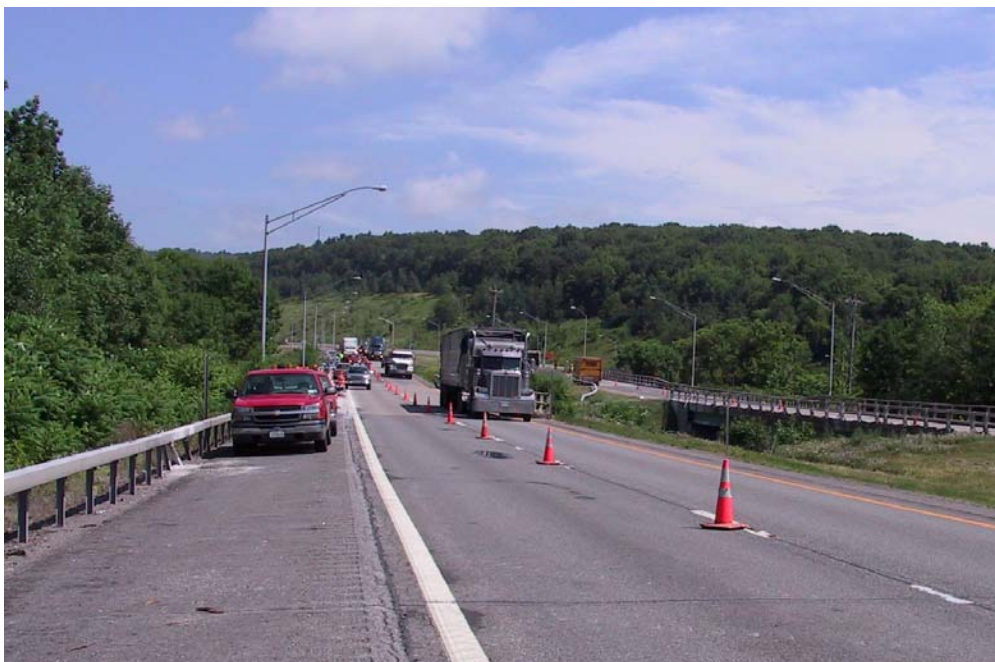
Photo 1. The site of the fatal incident where the southbound driving lane was closed to the traffic and the work zone was demarcated with orange traffic cones.

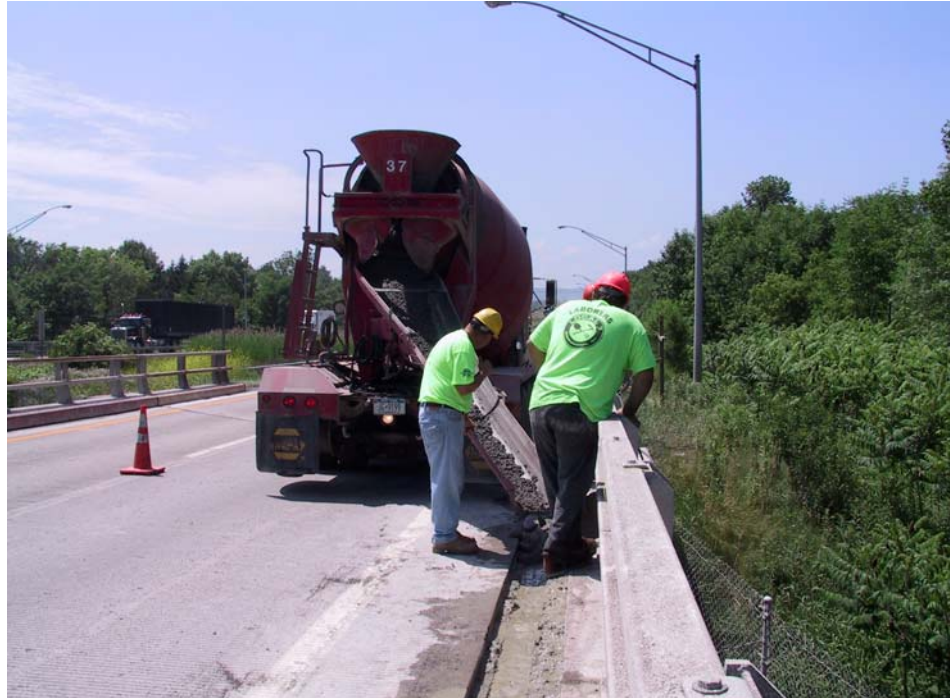
Photo 2. Paving company employees working at the rear end of the cement truck. (Photo was taken the day after work resumed, one month after the fatal incident. The cement truck and the workers pictured are in the same position as the victims at the time of the fatal incident.)

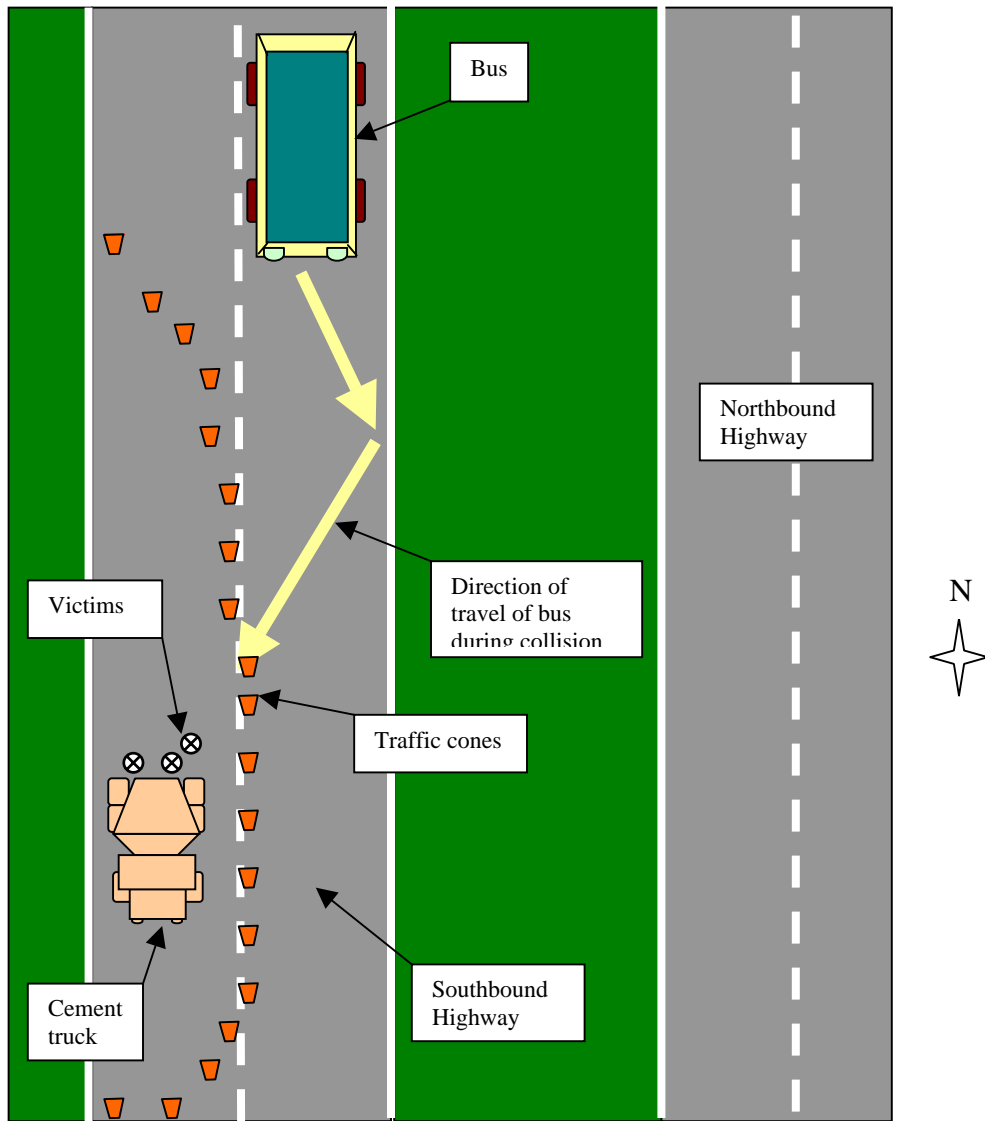
The section of the interstate highway where the fatal incident occurred was a four-lane divided highway for travel in a north/south direction. A grassy median divided the two southbound and two northbound travel lanes (Figure 1, pg. 9). The width of the southbound driving lane was approximately 11.6 feet and the width of the passing lane was 10.6 feet. The bridge shoulder on the east side was

Figure 1. Diagram of incident scene. (Diagram not drawn to scale).

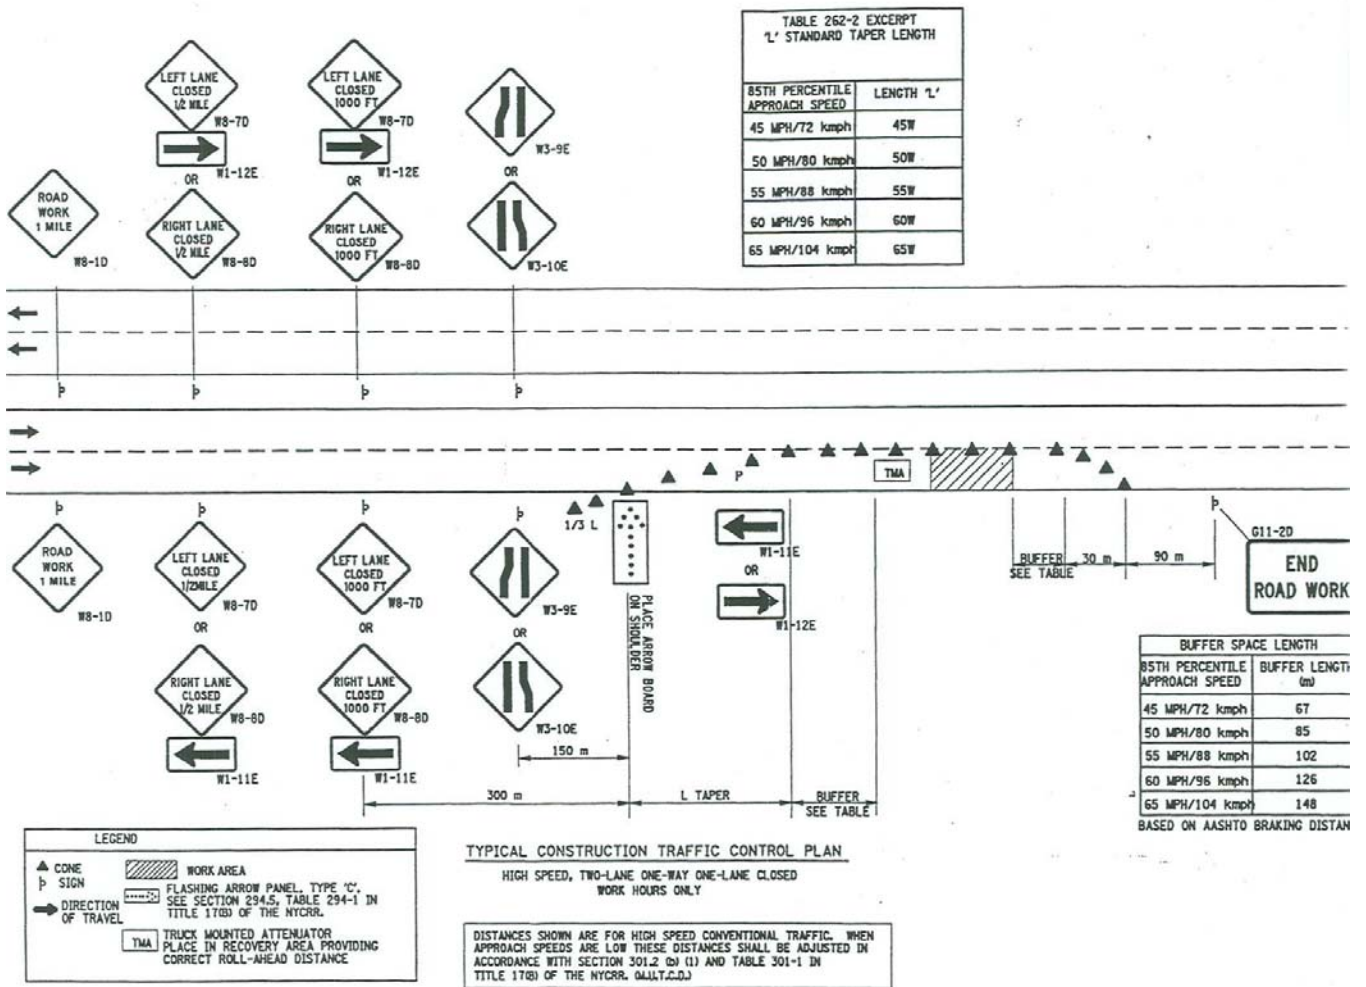
The temporary traffic control plan (Figure 2) was designed by NYSDOT based on the Federal Highway Administration's Manual on Uniform Traffic Control Devices (MUTCD). The speed limit was reduced to 55 mph within the temporary traffic control zone. The southbound driving lane was closed and the passing lane was open to traffic (Photo 1). According to the state police collision reconstruction report, signs reading "Construction Ahead", "Right Lane Closed", "Reduced Speed Ahead" and "55 MPH Speed Zone" as well as an electronic arrow board were placed along the 1.5 miles north of the construction zone to warn travelling motorists. The arrow board had an illuminated arrow pointing to the left (east) towards the passing lane, indicating that the driving lane was closed and motorists should merge into the passing lane. The work zone was demarcated by orange traffic cones starting approximately 0.2 miles north of the collision scene. The warning signs and orange traffic cones were set up by the paving company and inspected by NYSDOT inspectors. According to the NYSDOT representative, all traffic control devices were set up correctly.

Figure 2. Construction traffic control plan.

The NYSDOT suspended the construction operation immediately following the incident. The temporary traffic control plan was reviewed and revisions were made. Under the revised plan, the State Police Traffic Units sent trooper cars to patrol the work zone and enforce the traffic control. The NYSDOT also further reduced the speed limit within the work zone to 45 mph and the State Police increased the fine associated with speeding violations. On June 28, the first day when work resumed following the fatal incident, the troopers issued 40 speeding tickets at the incident site, according to the State Police.
