FATALITY ASSESSMENT AND CONTROL EVALUATION

Mechanic Electrocuted when a Mobile Light Tower Contacted Powerline Case Report 12NY018

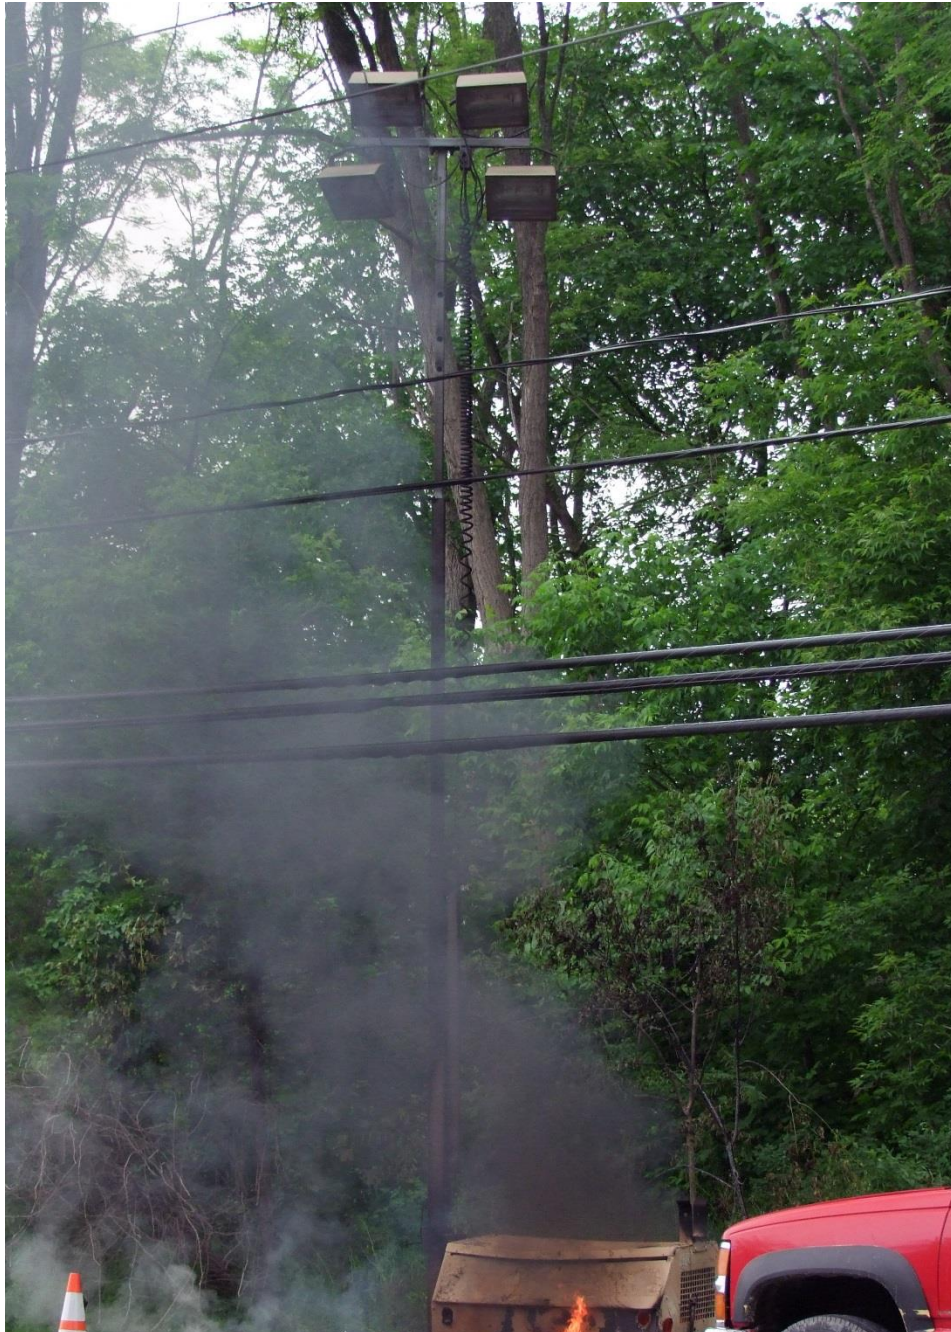
Photo 1. The mobile tower contacted a 7,620-volt powerline causing a fire and an explosion at the road construction site (photo courtesy of the town police department)

At the time of the incident, the victim was working alone on the roadside while other employees were working at a staging area. The incident was not witnessed. The light tower was positioned off the pavement on the grass under a 7,620-volt powerline that was approximately 25 feet above the ground. To lower the tower from its upright position, the victim first had to crank winch B to retract the telescopic mast and then crank winch A to fold the tower from upright to the horizontal storage position. For an unknown reason, the victim extended the mast instead of retracting it. The lights came in contact with the powerline and the victim was electrocuted. The electric current ignited the diesel fuel in the tank causing an explosion and setting the light tower on fire. The other workers heard the explosion and rushed to the site. They called 911 to summon emergency services. The police and fire department responded within minutes. The fire department had to wait for the power company to off the electricity before fighting the fire. It took approximately an hour to extinguish the fire. The victim was pronounced dead at 10:25am at the scene. The immediate cause of death was severe high voltage electrocution with thermal burns.

The manufacturer in this case required an overhead clearance of 40 feet for setting up the light tower. The maximum height of the tower was 30 feet. Therefore, the minimum safe distance was ten feet. The minimum safe distance was not maintained since the height of the powerline was approximately 25 feet and the tower was placed directly underneath the powerline.

Recommendation #1: *Employers should conduct a thorough jobsite survey to identify hazards including overhead powerlines and implement appropriate control measures prior to placing mobile light towers.*

Control measures should be taken to maintain a minimum safe distance between powerlines and mobile lighting equipment. If the minimum safe distance cannot be maintained, the employer should make arrangements with the power company to de-energize the powerlines or otherwise protect the powerlines from contact.

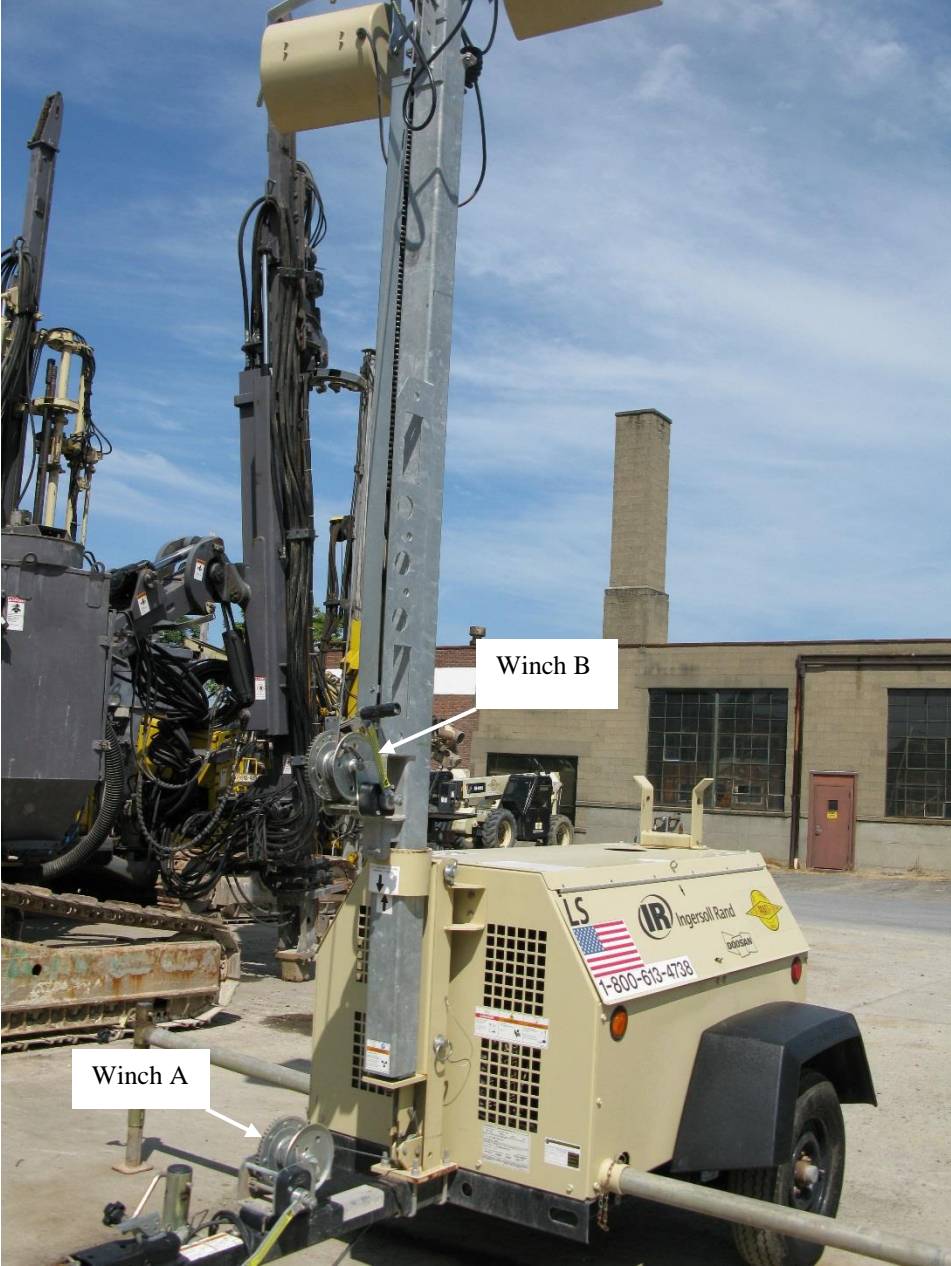
Photo 2. A Doosan mobile light tower Model LightSource, the same model as the one in the incident.

The mobile light tower was manufactured by Doosan Ingersoll Rand (Model: LightSource) and powered by a 4.6L diesel engine (Photo 2). The fuel capacity of the engine was 27 gallons (102 liters) and would allow lighting to be maintained for up to 52 hours. The light tower had four 1,000-watt metal halide lamps mounted on a telescoping mast made of galvanized steel. The telescopic mast could extend to 30 feet high with a 360° rotation and could be locked in position. The manufacturer stated in the Operating & Maintenance Manual: “*Danger: DO NOT raise or position light tower under electrical powerlines*”. There was a sticker on the tower warning the users of the electric shock hazard associated with positioning the light tower under powerlines (Photo 3).

The position and height of the tower was controlled by two hand winches (A and B). Winch A raised the tower from a horizontal position to an upright position and winch B extended (or retracted) the light tower (Photo 2). There was a yellow sticker on both winch handles stating that turning the handle clockwise would raise the tower and turning handle counter-clockwise would lower the tower (Photos 4). However, the Tower Operating Instruction posted on the tower did not specify which direction to turn the winch to raise or extend the tower. It simply stated that “operate winch A to raise tower” and “operate winch B to extend tower” (Photo 4).

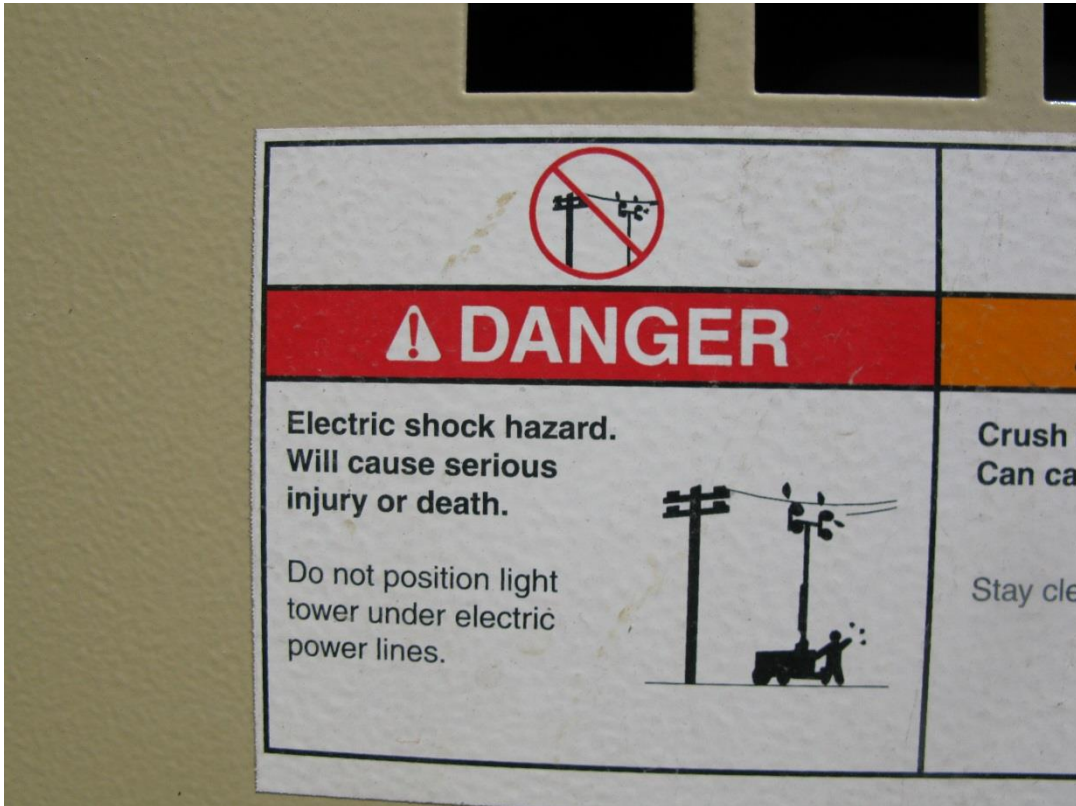
Photo 3. A manufacturer’s sticker on the Doosan light tower warned of the electric shock hazard associated with positioning a light tower under powerlines.

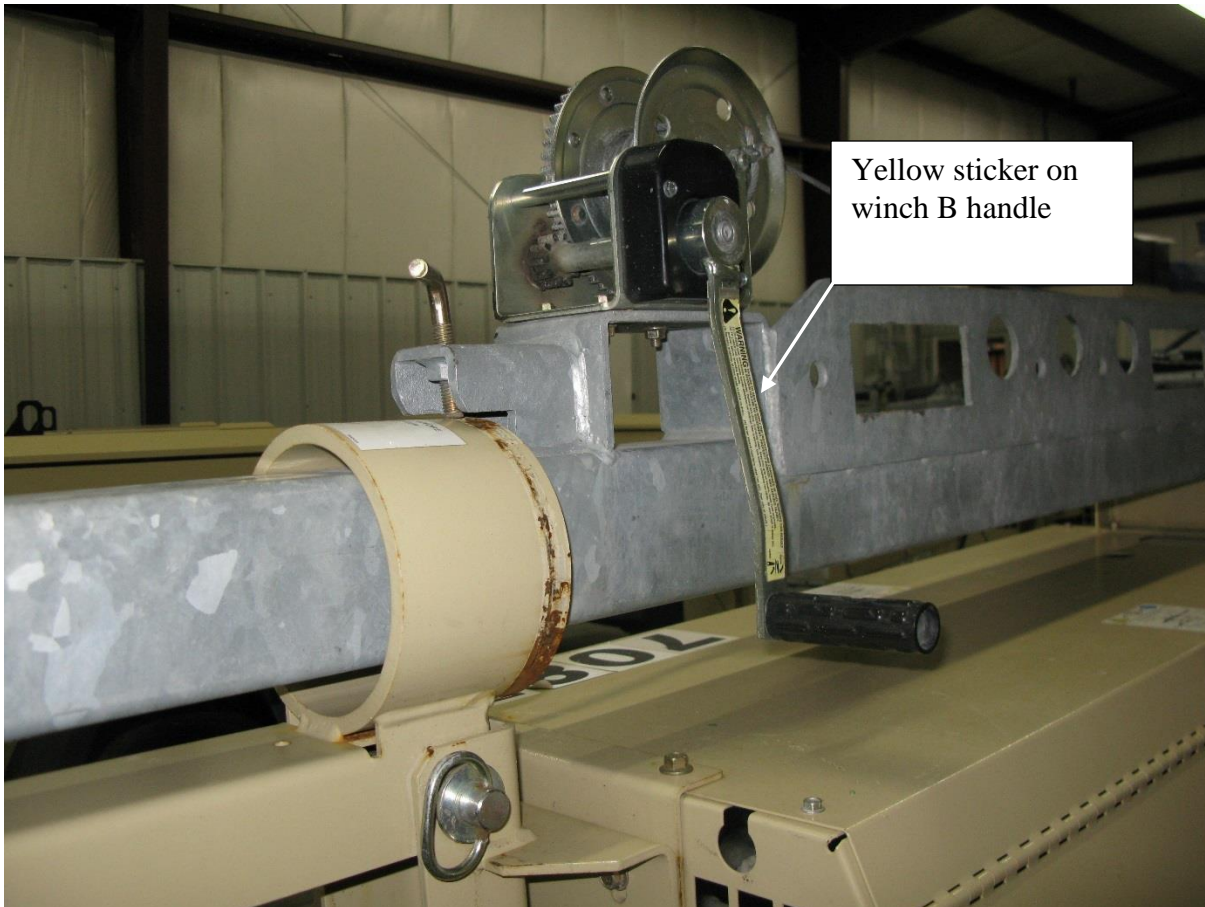
Yellow sticker on winch B handle

Photo 4. The yellow sticker on winch handles stated that “to raise load, turn handle clockwise” and “to lower load, turn handle counter-clockwise”.

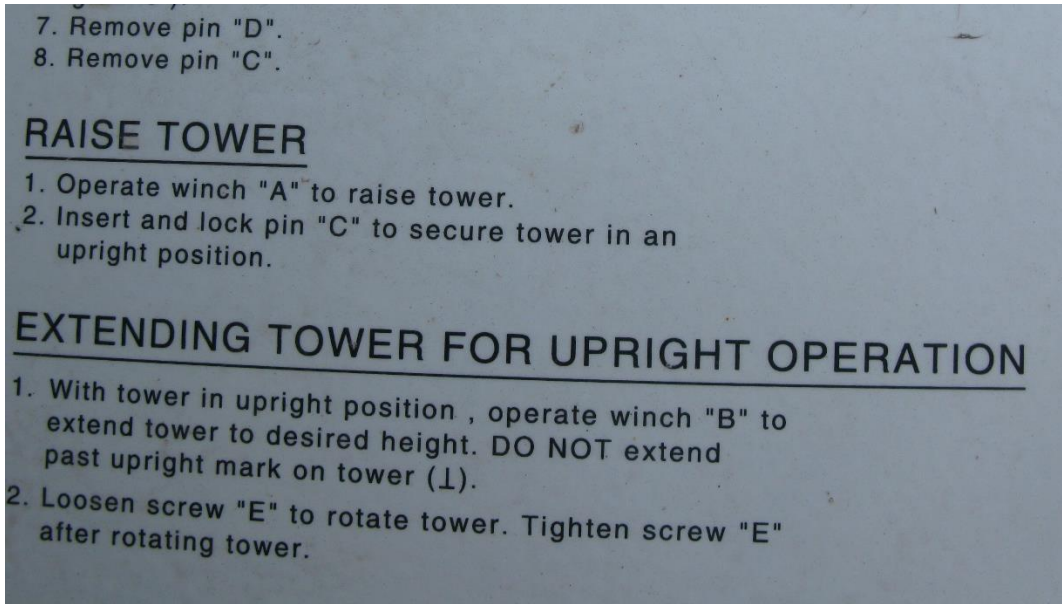
Photo 5. The Operating Instruction posted on the tower did not specify which direction to turn the winches to raise or extend the tower.

Discussion: The operating manual and the operating instruction posted on the tower in this case did not state the specific directions (clockwise or counter clockwise) to crank the winches for extending or

retracting the light tower. Manufacturers should provide clear instructions on which direction raises or lowers the tower.

Recommendation #6: *Manufacturers should provide clear and specific instructions in operating manual on how to raise and lower a light tower.*
