FATALITY ASSESSMENT AND CONTROL EVALUATION

Contractor Dies in Tractor Overturn while Skidding Logs
Case Report: 02NY055

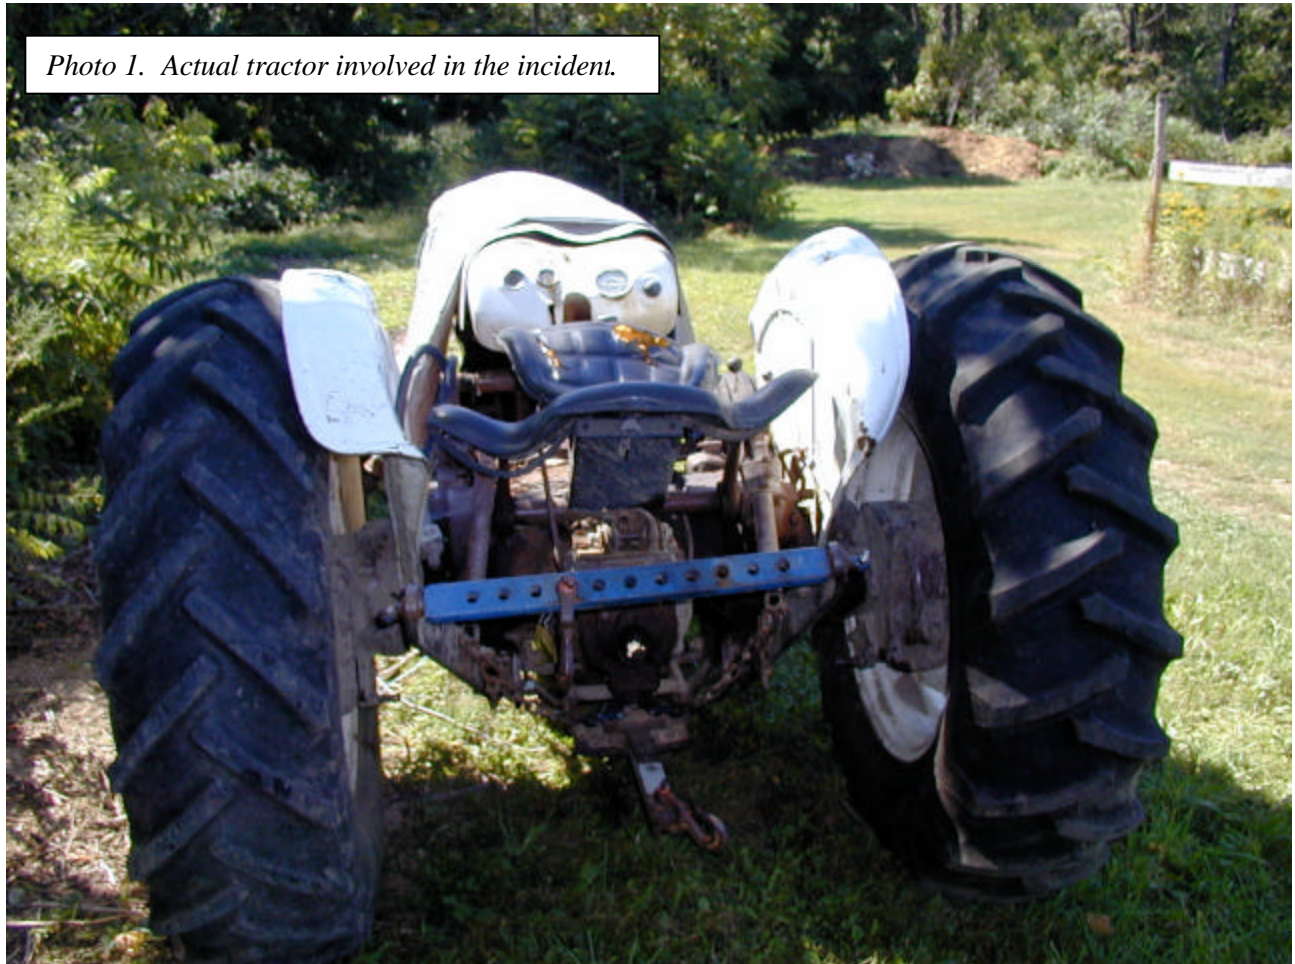
Prior to the incident, the victim had been dragging an 88-foot hemlock log with a butt diameter of 20 inches behind his 1969 vintage David Brown 990 tractor, an agricultural style tractor weighing approximately 4,600 pounds (*see Photo 1*). He utilized a logging chain that was wrapped around the butt end of the log and was connected to the back end of the tractor at the upper link of the three-point hitch. This location is well above the axis of the rear axle of the tractor and is not a hitching location. The drawbar hitch is approximately 3 feet below the location of the upper link. Normally, hitching points on this style tractor would be the drawbar or connections to the lower three-point hitch arms. Additionally, the tractor was travelling up a 20-degree incline at the time of the rearward overturn. In addition to the improper hitching technique and the effects of the incline, the mass of the 88-foot log significantly impacted the drag on the tractor. This log was skidding along the ground and it is very likely that the butt end of the log dug into the soil, which anchored the log, and resulted in stopping the tractor. Since the tractor drive wheels were turning with the tractor being anchored from behind, the rotational movement through the axles and wheels resulted

in the tractor rotating backwards around the rear axle, coming to a rest upside down on the victim. Rearward overturns such as this occur in less than one seconds' time thus not allowing the operator sufficient reaction time to avoid the overturn. The victim remained in the operator location during the overturn being pinned underneath the tractor with his knees crushed up against his chest. It is believed that the overturn may have occurred up to one hour before being discovered by the elderly farmer, although it is believed that he died immediately following the overturn.

Photo 1. Actual tractor involved in the incident.

Recommendation #1: *Equip all tractors with roll-over protective structures (ROPS) in order to protect the operator from injury in the event of a tractor overturn. Seatbelts are an integral part of ROPS protection and should be worn by tractor operators while working.*

Discussion: The tractor involved in the incident did not have ROPS protection, and while it would not have prevented the overturn in this scenario it may have protected the operator from crushing injuries if so equipped. It is important for tractor operators to wear seatbelts when the tractor is equipped with ROPS in order to keep them in the zone of protection in the operator position in the unlikely event of an overturn.

Discussion: Pulling chains should only be hitched to the frame drawbar or the drawbar on the three-point hitch. It is never recommended to attach chains above the axis of the rear axle as this adversely affects the center of gravity of the tractor and significantly lightens the front end of the tractor during pulling. In this scenario, by attaching the logging chain to the upper link that was above the rear axle, the victim created a downward force at the back end of the tractor. This, in combination with the mass of the log and the incline, contributed to the rear overturn direction. It is recommended that tractor operators “hitch low and pull slow”.
