FATALITY ASSESSMENT AND CONTROL EVALUATION

## Crane Boom Collapse Kills Man during Disassembling

Case Report: 08NY011

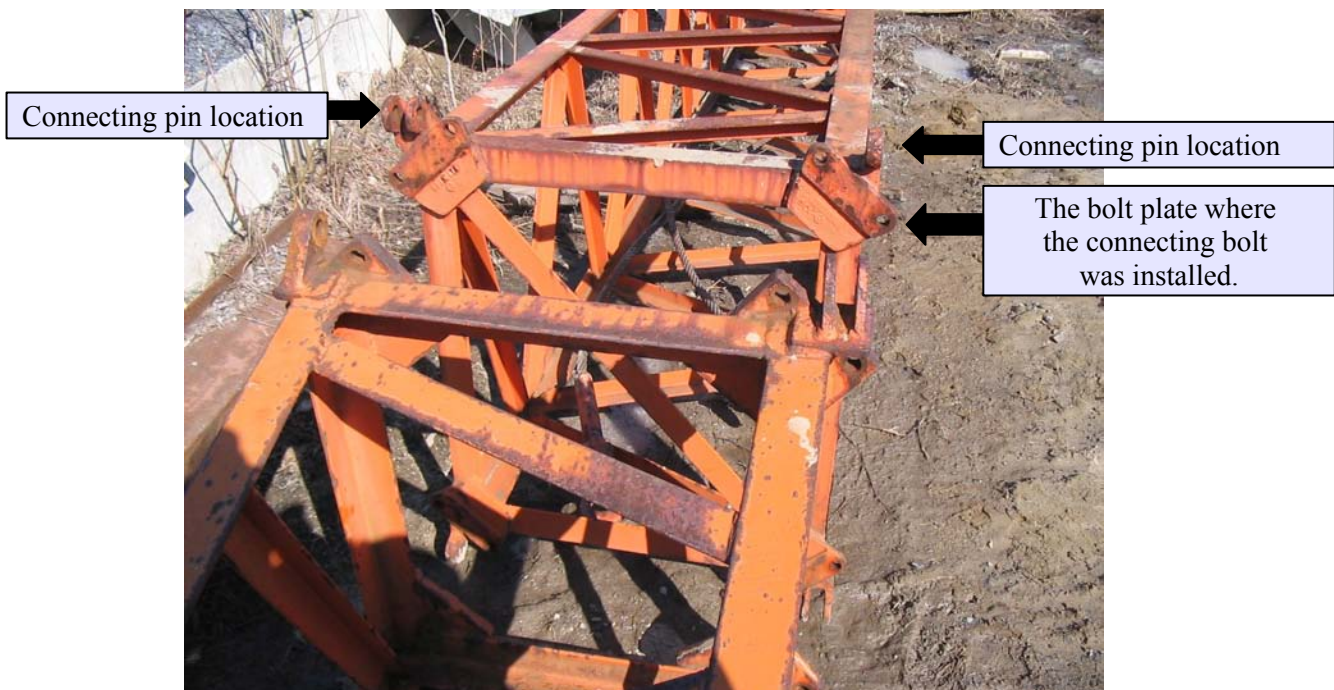
For the crane to be repaired and inspected, the boom had to be disassembled into individual sections. The boom was 55 feet long and composed of four sections: a base (15 feet), boom extension I (20 feet), boom extension II (10 feet) and a tip with the hook (10 feet). Adjacent sections were connected with eight bolts and four connecting pins (Photo 1). Each connecting pin was secured with a cotter pin at its tapered end (Photo 2). The connecting pins were inserted from outside the boom; the cotter pins were inside the boom.

*Photo 1. The photo illustrates the connecting ends of the two adjacent boom sections. There were eight bolts and four connecting pins connecting the two boom sections (Photograph courtesy of OSHA).*

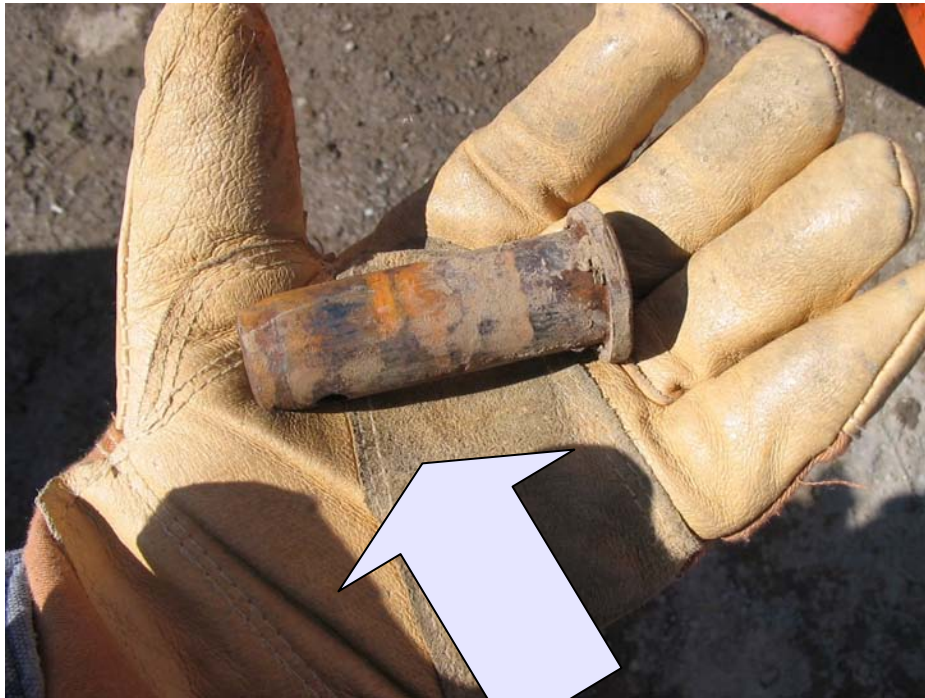
*Photo 2. A connecting pin with the arrow showing where the cotter pin was inserted.  
(Photo courtesy of OSHA)*

**Recommendation #4:** *When assembling a crane boom, workers should be instructed to insert the connecting pins with the cotter pins placed on the outside of the boom so that no worker has to get under the boom to remove them during disassembly.*

**Discussion:** During boom assembly, with all boom sections blocked and fully supported, workers should be instructed to insert the connecting pins with the cotter pins on the outside of the boom frame without positioning themselves under the boom. This will enable a worker to remove the pins from outside the boom during boom disassembly. Some boom types are designed to allow the pins to be installed from the outside with cotter pins inside the boom to avoid pendant line snag. When dismantling this type of boom, it is especially important to use blocking to support all boom sections and prevent sudden boom movement. Workers should use the appropriate tool, such as a long bar, to drive the pins out from outside the boom. No worker should ever get under the boom to remove pins.

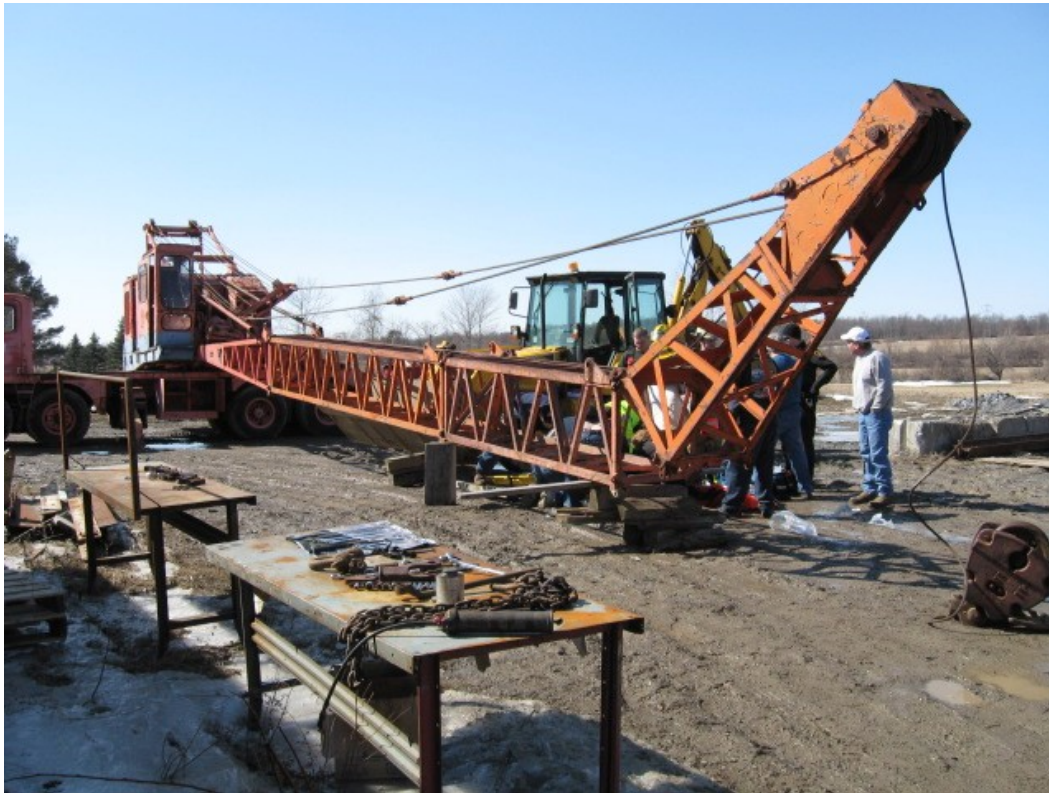
The post incident investigation revealed that in addition to the removal of the sixteen bolts, the victim had also removed four lower connecting pins: two between the tip and extension II and two between extensions I and II. A 12-pound sledgehammer was found lying next to the victim. The victim positioned himself under and inside the boom so that he could remove the connecting cotter pins that were inserted inwards and drive the pins out. It was postulated that the victim first removed the two lower pins connecting the tip and the extension II and the two sections were "stuck"; this resulted in the boom remaining connected initially. When the victim used the sledgehammer to drive the last pin out, the boom buckled at two locations: between the tip and extension II and between extensions II and I (Photo 3). The victim was under and between extensions II and I; he was crushed by the extension II (Figure 1). The owner called 911 to summon emergency medical services (EMS), who arrived within minutes. The victim was transported to a hospital where he died of severe head and torso injuries.

*Photo 3. The boom assembly buckled at two locations: between the tip and extension II and between extensions I and II. The victim was crushed by extension II. Blocking under the boom was placed after the incident. (Photo courtesy of OHSa)*

**Discussion:** When assembling/disassembling a crane boom, all personnel should strictly follow the manufacturer's specified procedures. The direct cause of this fatality was that the victim did not follow the disassembly procedure sequence and positioned himself under the boom to remove the connecting pins on the sections behind the pendants. The failure to use blocking to support the boom sections also contributed to the fatal incident, as blocking can stabilize the boom and prevent the boom movement (collapse) that can cause fatal injuries.

Employers should ensure that workers use proper blocking to support each boom section to prevent boom sections from moving when disassembling cranes. Hazard warning signs should be posted at or near all pin connections.
