FATALITY ASSESSMENT AND CONTROL EVALUATION

Guatemalan Tree-Service Worker Killed when Pulled into Brush Chipper Case Report: 05NY034

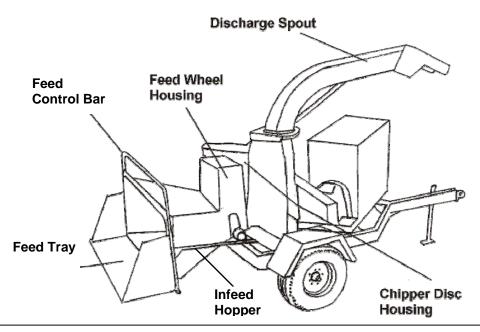
On May 4, 2005, the victim and his employer were trimming trees behind a residence. A brush chipper was used to grind up the cuttings. The brush chipper, purchased by the tree-service owner ten year ago, was a hand-fed portable model (Figure 1) and could process materials up to 12 inches in diameter. The machine consists of a feed mechanism, a rotating chipper drum, and a power plant. Tree cuttings are fed into the machine through a feed chute, or infeed hopper. At the end of the chute,

Figure 1. Diagram of wood chipper model involved in incident. (Courtesy of National Institute for Occupational Safety and Health, FACE Report 98-13).

two feed wheels are arranged one above the other to pull material into the chute. The feed wheels grab the tree cuttings and forces them into the knives mounted inside on a rotating drum. The drum operates at a high rate of speed and pushes the chipped wood through a discharge spout for removal and transport.

The brush chipper is equipped with a feed control bar (a.k.a., safety bar) located around the opening of the feed chute. The control bar operates the feed wheels and has three positions: feed, off (neutral), and reverse. An operator pulls the bar toward the feed chute to activate the feed wheel rotation and pull the material into the chipper, places the bar in the middle (neutral) to stop the feed wheels, or pushes the bar toward the chipper to reverse the feed wheels and back the material out of the chipper. Since the feed control bar was around the infeed hopper, a worker caught in the feed mechanism may not be able to activate it.

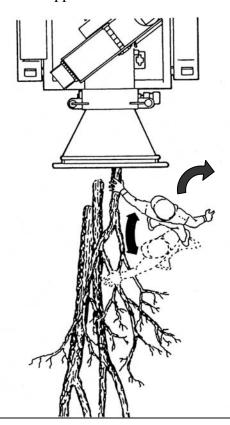
Figure 2. Safe feeding pathway: material fed from side, operator walks away immediately following feeding. (Courtesy of Michigan Occupational Safety and Health Administration, Pub OSC-6125).

- never place hands or feet inside the feed chute;
- always stand to the side of the infeed hopper when feeding the brush chipper. This minimizes the risk of entanglement in branches and allows quick access to the feed control bar to turn off or reverse the feeding mechanism. (Because of differences among machines, the manufacturer's operating manual should be consulted for guidance. Safe feeding of some disctype chippers requires the worker to be on the right side);
- immediately walk away once the machine has grabbed the material and been fed through the chipper knives (see Figure 2);
- feed brush and limbs into the infeed hopper butt end first; and
- lay short/small material on top of longer material to feed or use a push paddle to push short or thorny brush through the infeed hopper.
