FATALITY ASSESSMENT AND CONTROL EVALUATION**Mechanic Dies after being Pulled into a Snow Thrower****Case Report: 07NY013****SUMMARY**

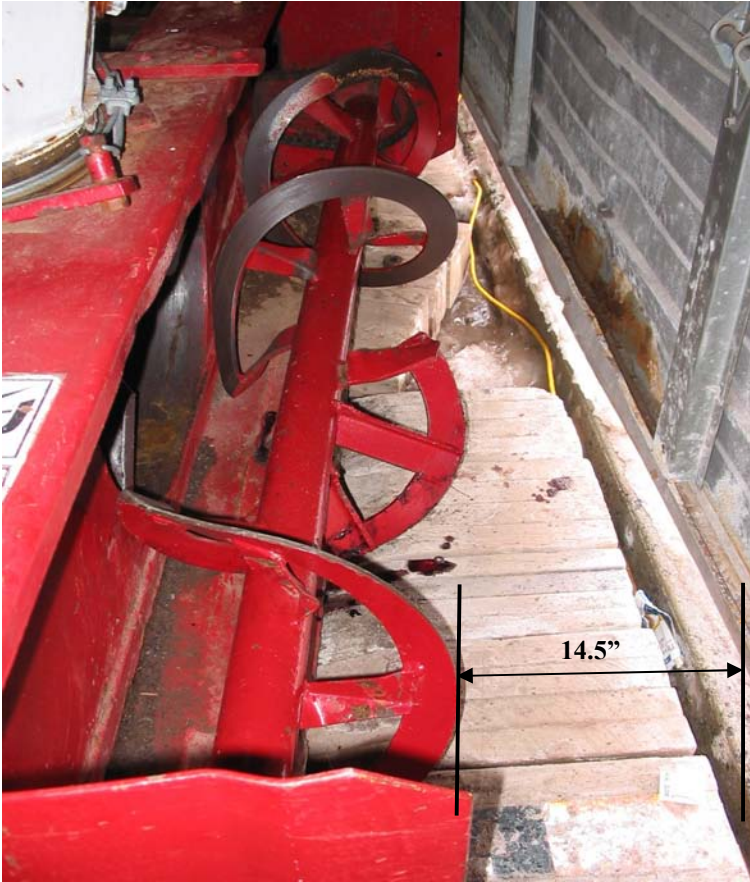
The operator reported that she had disengaged the auger prior to parking the snow thrower in the garage with the auger next to the garage door in an angled position. The width of the garage door was 124 inches; it was a manual door with a latch on the right side. The auger was 72 inches wide. The clearance between the left front end of the auger and the door was measured 3.75 inches; the clearance between the right end of the auger and the door was 14.5 inches (Photo 2).

Photo 2. The victim was caught on the side where the clearance between the door and the rotating auger was 14.5 inches (Photo courtesy of OSHA).

move the snow thrower out of the garage. He started the engine, engaged the PTO, got off the tractor, and positioned himself between the garage door and the auger to open the door. The clearance between the door and the auger was 14.5 inches. His flannel shirt was caught by the rotating auger and he was pulled into it. The co-workers immediately called 911 and notified the resort management. The local emergency rescue squad and ambulance services responded and arrived on site within ten minutes. The victim was pronounced dead at the scene. It was estimated that the victim had been dead for several hours. The Medical Examiner reported in the toxicology report that the victim's blood alcohol concentration (BAC) was 0.12%. The legal limit of BAC for operating motor vehicles in New York State is 0.08%.

Recommendation #1: *Employers should ensure that all their snow removal equipment are equipped with operator-presence controls that are functioning properly.*

Although a safety interlock is required by American National Standard Institute (ANSI), not all tractors are equipped with the interlock. Employers should consult the manufacturers to ensure that their snow throwers have the operator-presence controls. If a snow thrower does not have the control, the employer should consult with the manufacturer for retrofitting. Employers should ensure that the safety features on the snow removal equipment are working properly. Equipment with a malfunctioning safety interlock should be immediately removed from service. It should not be allowed back into service until it is repaired.
