# STATE OF NEW YORK DEPARTMENT OF HEALTH

## FATALITY ASSESSMENT AND CONTROL EVALUATION

### Farm Worker Dies during Forage Chopper Entanglement Case Report: 03NY049

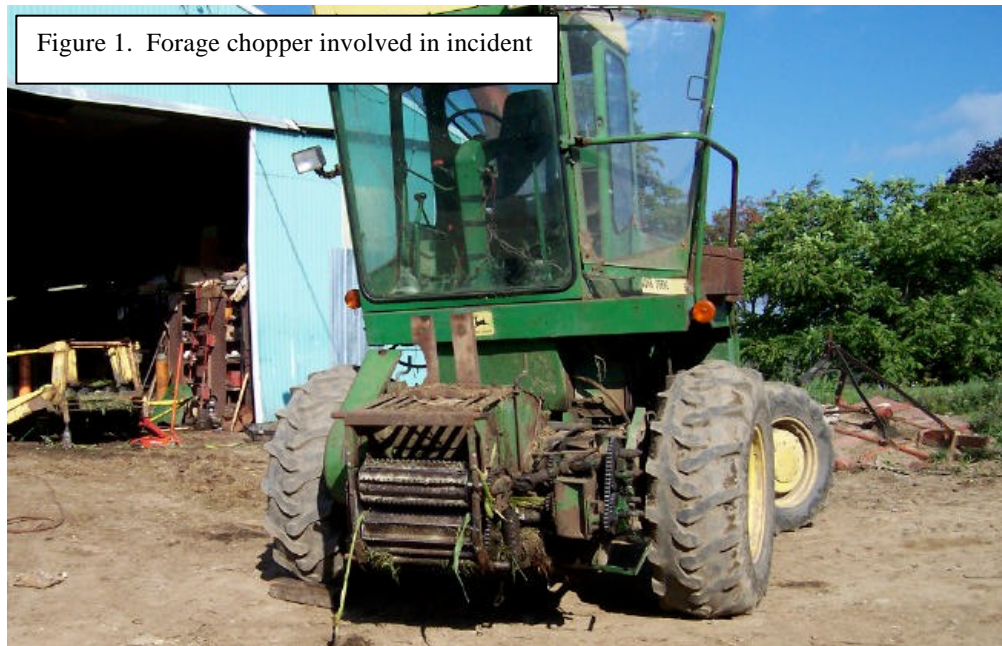
On Saturday, September 6<sup>th</sup>, 2003, the victim and a co-worker were chopping four bales of hay using a 1970s vintage self-propelled 4-wheel drive John Deere 5400 forage chopper, one of the first models of this type of equipment (Figure 1). The hay was being added to the total mixed rations (TMR) given to the cows at the suggestion of a nutritionist in order to increase milk production for the herd. For the hay to be mixed properly into the TMR in a mixer, the bales had to first be put through a chopper. To do this, the bales were flaked into sections, and then hand fed through the intake rollers of the forage chopper. The intake rollers would then feed the sections of bales into the knives that were spinning at approximately 900 rpm. On the day of the incident, the forage chopper did not have a hay or corn head attachment in place as the head of the chopper had been removed specifically so that the workers could feed hay directly into the chopping unit.

**Discussion:** In this case the forage chopper had been modified by removing the chopping head from the machine. The chopper was then placed in a stationary position inside the bunker silo with hay being fed directly into the interior mechanism of the machine. The original equipment design is intended to be a self-propelled unit that travels through the field harvesting and processing material as it travels.

was standing. These rollers are not normally exposed and would normally present no hazard since they would be effectively guarded by the chopping head; however the chopping head had been removed. Additionally, under normal machine operating conditions, workers would not be located near this mechanism since they should be located in the operator position in the cab of the chopper.

**Discussion:** In this scenario, the chopper was knowingly operated with components missing. The chopping head had been removed, exposing the intake rollers, thereby presenting a hazard to nearby workers. Guards and shields should be kept in place on all large machinery to ensure the safety of workers.
